Core Buildup Repair Using a Clear Matrix: A Case Report and Clinical Technique

R Ajlouni • K Ajlouni • GE Denehy

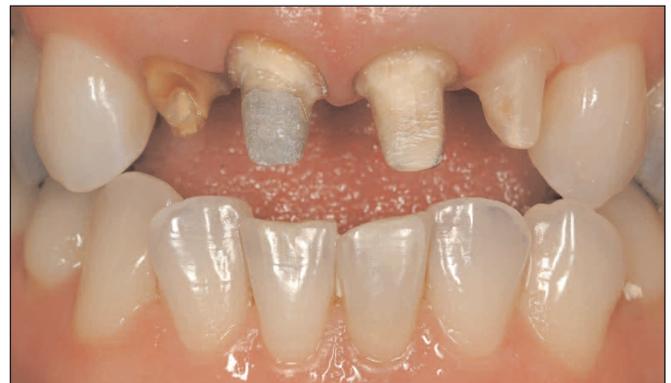
Figure 1. Preoperative facial view of broken core on upper right lateral incisor tooth #7.

At the cementation appointment, the patient reported breaking one of the provisional restorations while eating. Examination revealed a broken core buildup on tooth #7 (Figure 1). The patient desired to have the crowns cemented at that visit and did not want to go into a new provisional period required for a new buildup and crown preparation. These crowns were in the esthetic zone, so the recreation of ideal fit and alignment was crucial for successful treatment.

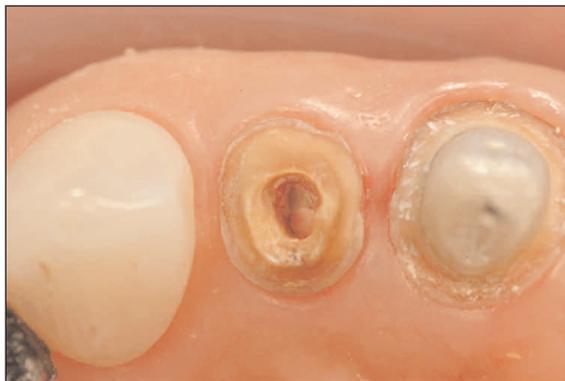
Figure 2. Lingual view of broken upper right lateral incisor tooth #7. There was enough interradicular and coronal tooth structure to bond the light cured resin based composite without the need for a post.

After cleaning the root canal space, there was enough interradicular and coronal tooth structure to bond resin-based composite and provide adequate retention and support for the crown without the need for a post (Figure 2). A decision was made to use light-cured resin composite to replace the fractured core buildup. The

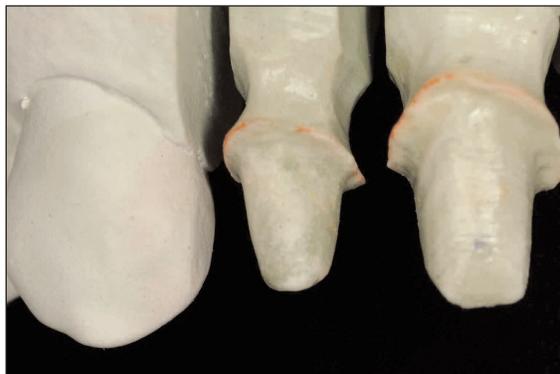
Figure 3. Facial view of working dies. Note the original contour of the core buildup on the upper right lateral incisor tooth #7.

A clear polyvinyl siloxane (PVS) impression was taken from the preparation model (Figure 3) using Clearly Affinity (Clinicians Choice, London, Ontario, Canada). One tooth on each side was included in the impression for stabilization of the matrix in the patient's mouth (Figures 4 and 5).

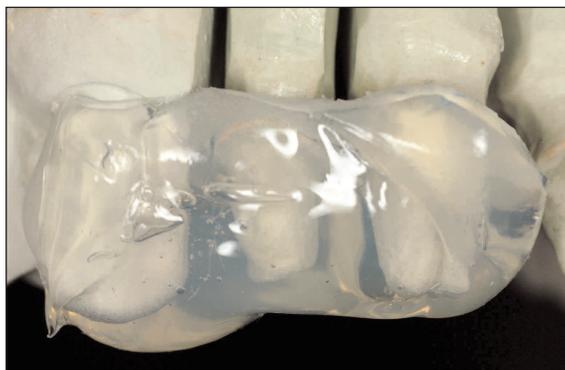
Figure 4. Clear polyvinyl siloxane (PVS) impression of the preparation model (Clearly Affinity, Clinicians Choice, London, Ontario, Canada). One tooth on each side was included in the impression for stabilization of the matrix in the patient's mouth.

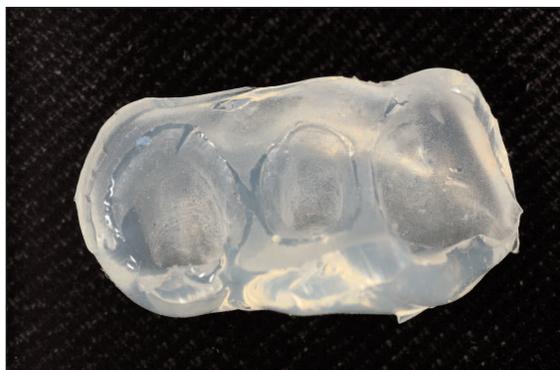
Figure 5. Internal view of the clear polyvinyl siloxane matrix. Note the detailed reproduction of the die.

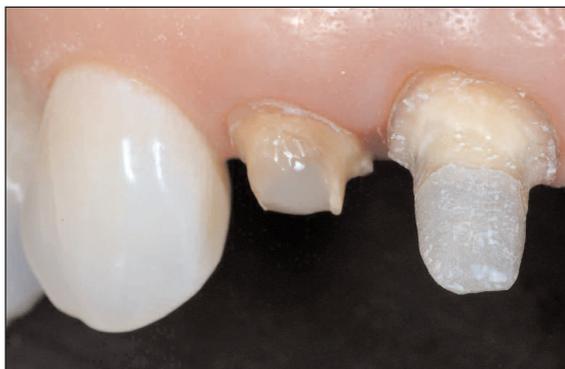
Figure 6. Core buildup was done by incremental layering of resin-based composite. Incremental placement continued until the canal and chamber were filled to the most coronal portion of the tooth.

manufacturers instructions using a high-intensity halogen light (Optilux 501; Demetron/Kerr Corp). Incremental placement continued until the canal and chamber were filled to the most coronal portion of tooth structure (Figures 6 and 7). The resin-based composite (Z-250, 3M ESPE), applied inside the clear polyvinyl siloxane matrix and positioned on the adjacent teeth (Figure 8), was then light cured through the matrix for five seconds. The matrix was removed, excess material was removed using a #12 Bard Parker blade (Becton, Dickinson and Co, Franklin Lakes, NJ, USA) and the core buildup was cured from all directions for 40 seconds (Figure 9). The crowns (Figure 10) were tried in and occlusion was checked. The esthetics were checked visually by both the dentist and patient, then the crowns were adhesively bonded, occlusion checked and centric and eccentric contacts adjusted (Figure 11).

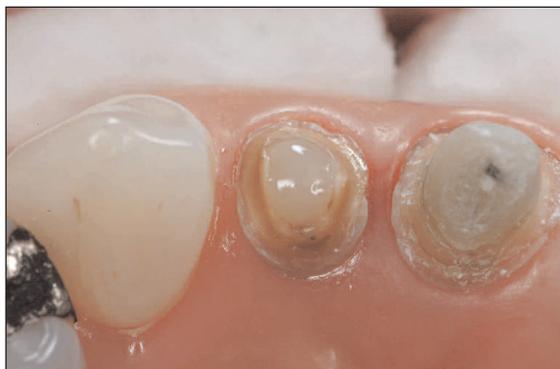
Figure 7. Lingual view of core buildup after incremental layering of resin-based composite. Increment placement continued until the canal and chamber were filled to the most coronal portion of the tooth.

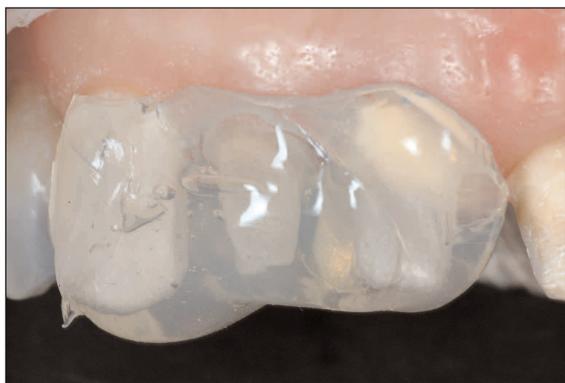
Figure 8. The polyvinyl siloxane matrix was used to press and shape the final resin-based composite layer. The resin-based composite was then cured through the matrix using a high-intensity halogen light.

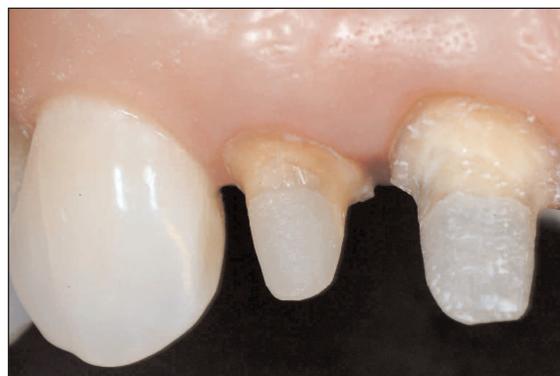
Figure 9. Facial view of the completed resin core. Note reproduction of the original contours and alignment.

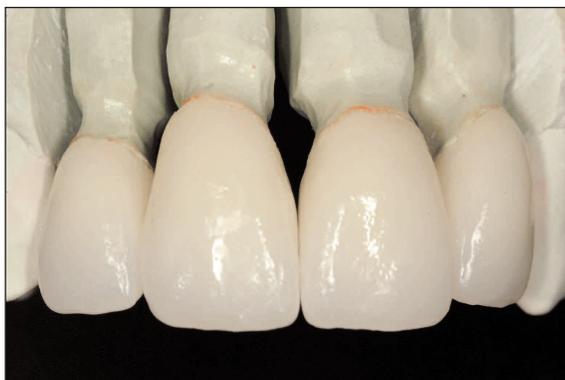
Figure 10. Facial view of the Procera crowns on the working die.

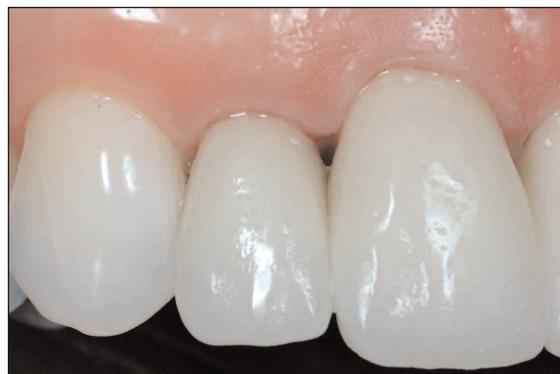
Figure 11. Facial view of the completed restorations. Note the natural shade matching and esthetics.
