Clinical Technique/Case Report

Composite Veneering of Complex Amalgam Restorations

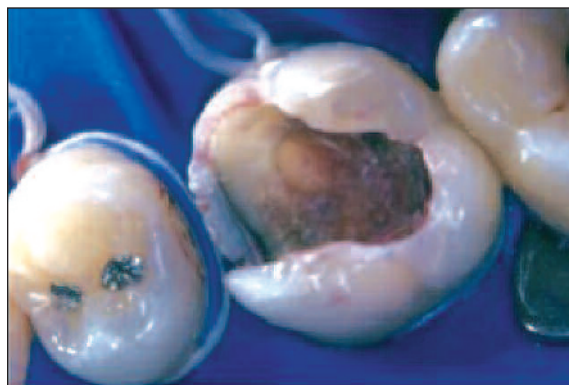
Figure 1. Cavity preparation after caries removal and prior to finishing of the margins.

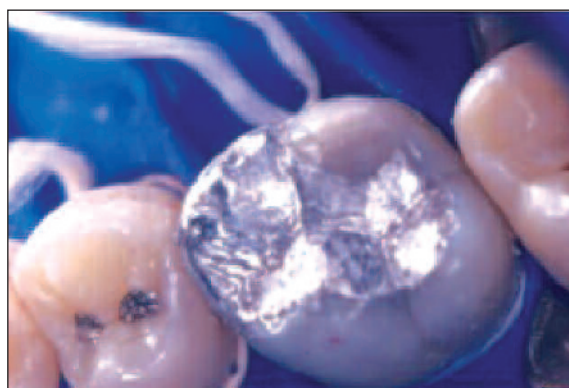
Figure 2. Carved and burnished amalgam restoration after matrix removal.

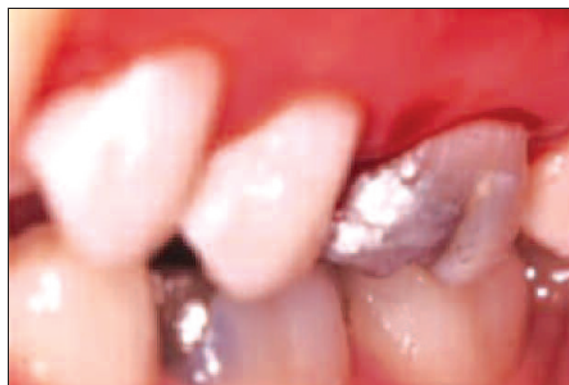
Figure 3. Buccal view of the restoration after removal of the rubber dam.

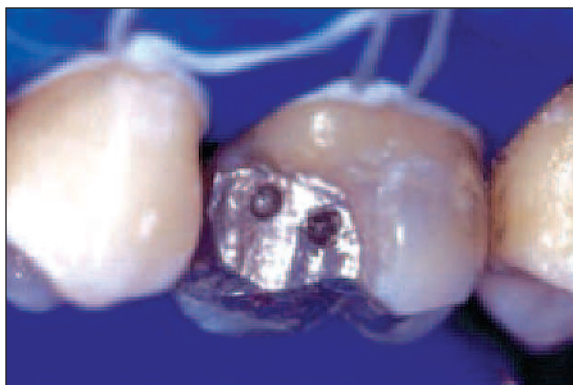
Figure 4. Buccal amalgam surface reduced and two retentive areas placed.

patient agreed with the treatment proposed. Then, the color shade was taken and the rubber dam was placed. The buccal amalgam surface was ground to a depth of 2 mm using diamond burs (#4138, KG-Sorensen, Barueri, SP, Brazil). With a #1090 cylindrical diamond bur (KG-Sorensen, Barueri, SP, Brazil), two small holes were placed in the ground amalgam surface to improve mechanical retention (Figure 4). Powder and

To provide some mechanical retention between the materials used in this case, the amalgam surface was ground with a diamond bur. Eidelman and others²⁰ stated that the bonding system could penetrate into the roughened surface produced by the diamond bur, creat-

ing a micromechanical interaction with the composite. Also, small holes were prepared in the ground amalgam surface, similar to the amalgapin technique.²¹ These holes should improve the resistance to displacement of the composite veneer caused by occlusal forces.²²

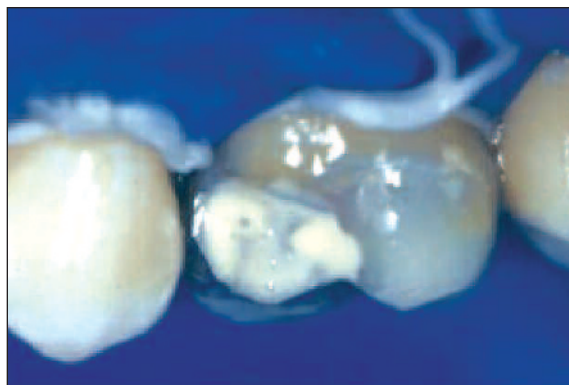
Figure 5. Thin layer of RMGIC applied over cut amalgam surface.

liquid of the resin-modified glass ionomer cement (RelyX Luting Cement, 3M/ESPE, St Paul, MN, USA) were mixed, and a thin layer was applied into the retention holes (Figure 5) and photo activation was conducted for 40 seconds. The enamel was conditioned with 37% phosphoric acid for 20 seconds, followed by washing, and two layers of Adper Single Bond (3M/ESPE) were applied, which were photo activated for 20 seconds. The veneer was built with composite (Filtek Z250, 3M/ESPE), with two increments 1 mm each, each of which were polymerized for 40 seconds (Figure 6). The rubber dam was removed, the occlusion was checked and finishing and polishing were completed with multilaminated burs and rubber points (amalgam) and disks (Sof-Lex, 3M/ESPE) for the composite (Figures 7 and 8). After six months, the patient returned, and the restoration was evaluated, exhibiting good esthetic and functional results (Figures 9 and 10).

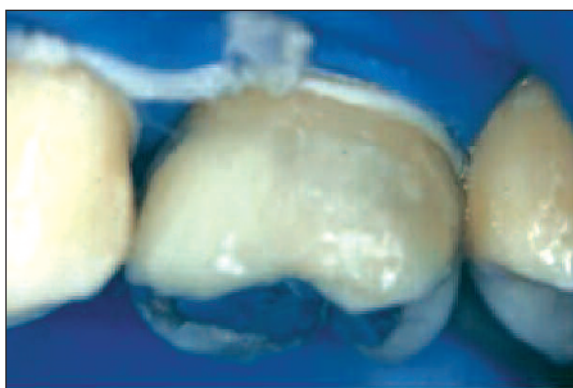
Figure 6. Composite placed in two increments following enamel etching and application of adhesive system.

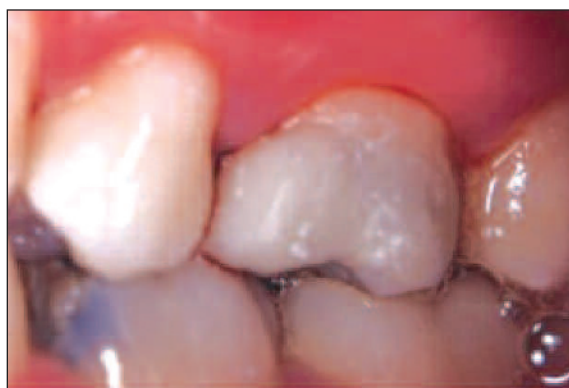
Figure 7. Buccal view of composite veneer after rubber dam removal.

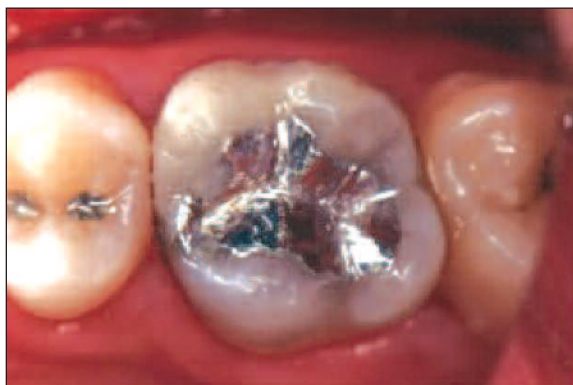
Figure 8. Occlusal view of the polished amalgam/composite restoration.

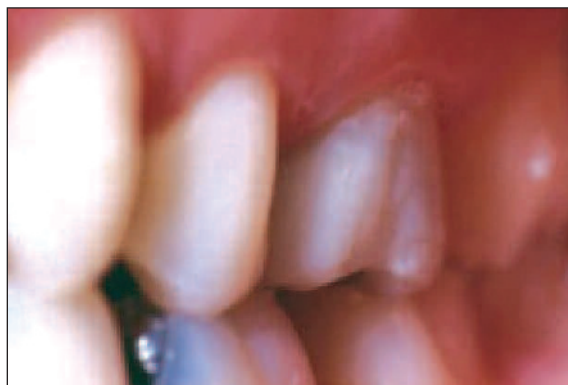
Figure 9. Six-month buccal view of the restoration showing an adequate esthetic result.

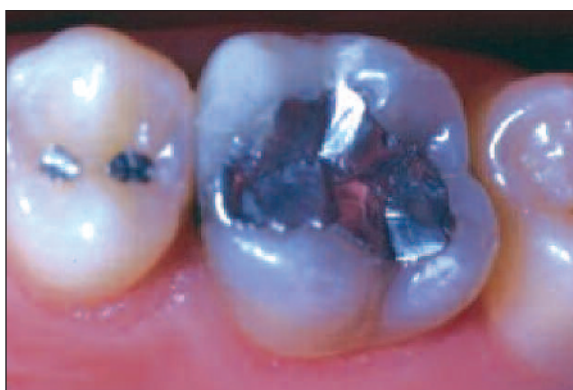
Figure 10. Six-month occlusal view showing good esthetic and functional result.
