## Clinical Technique/Case Report

# Restoration of Erosion Associated with Gastroesophageal Reflux Caused by Anorexia Nervosa Using Ceramic Laminate Veneers: A Case Report

M Hayashi • K Shimizu  
F Takeshige • S Ebisu

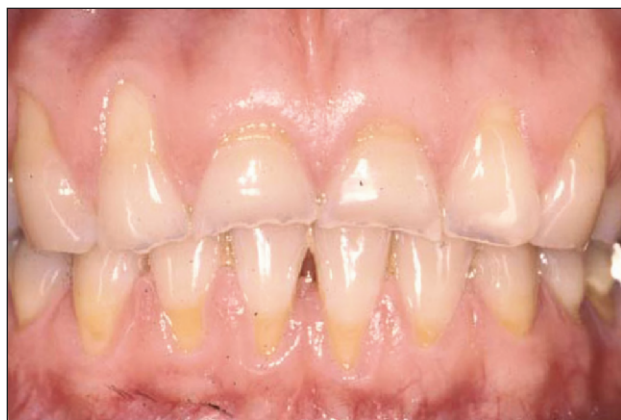
Figure 1. Severe erosion and attrition were found in maxillary incisors.

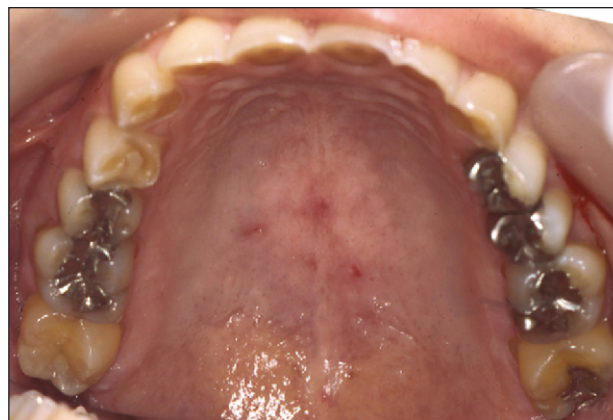
Figure 2. Maxillary occlusal view showing extensive erosion of virtually all teeth.

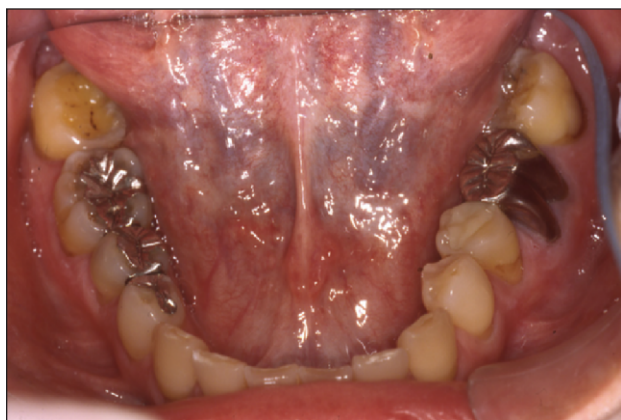
Figure 3. Mandibular occlusal view showing erosion in posterior teeth.

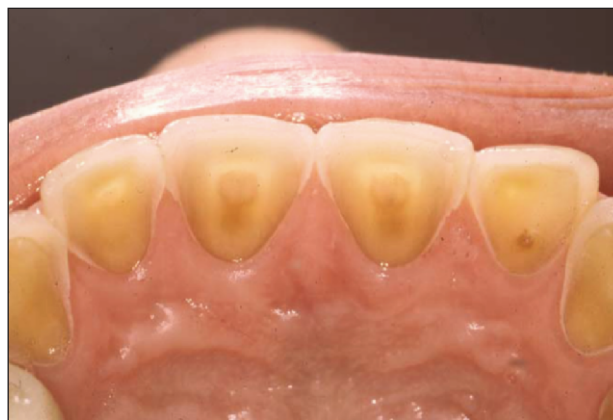
Figure 4. The most severe erosion was observed on palatal surfaces in maxillary incisors.

Severe erosion involved all her teeth, except the mandibular incisors. The most severe erosions of enamel and dentin were found on the lingual and incisal surfaces of the maxillary anterior teeth, and pulp cavities were identified under transparent illumination (Figure 4). Severe erosion was also found on the palatal and occlusal surfaces of the maxillary premolars (Figure 5). Those areas showed extreme thermal sensitivity. In both the maxillary and mandibular arches, the occlusal surfaces of her molars showed an elevation of metallic and composite restorations, while less erosion was found on the buccal surfaces (Figures 2-3 and 5-7). The patient showed a Class I occlusal relationship, but the vertical dimension was not maintained (Figure 1). Cuspal collapse in the molars did not allow for functional occlusion (Figures 4-7). There was a low frequen-

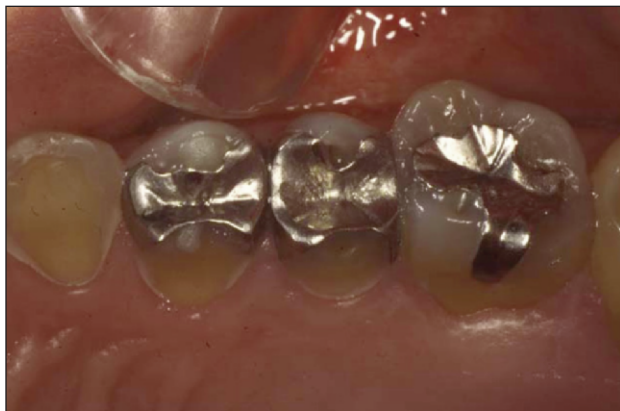
Figure 5. Severe erosion was also observed on palatal surfaces in maxillary left premolars. Their palatal cusps were entirely eroded.

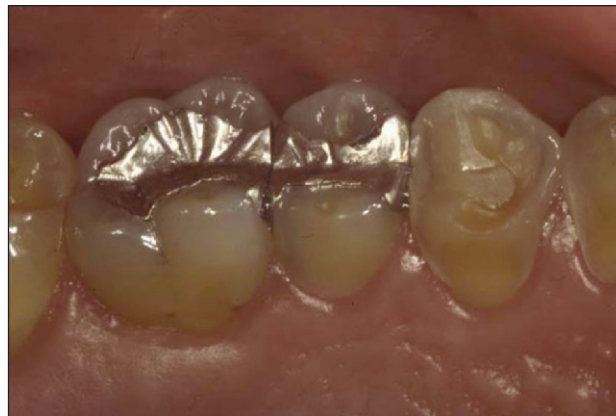
Figure 6. Metallic restorations were elevated on occlusal surfaces in maxillary right premolars.

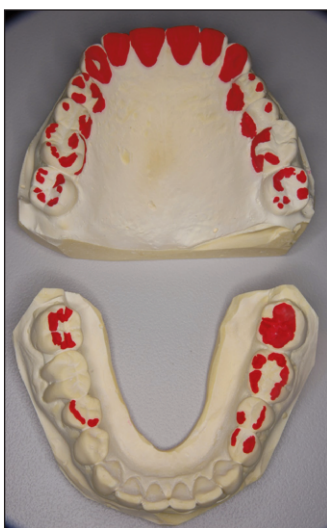
Figure 7. Preoperative plaster models with red shading to identify the severely eroded areas.

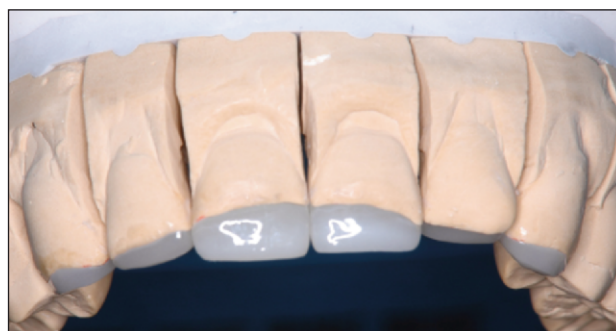
Figure 8. Ceramic veneers for maxillary incisors were fabricated on dies.

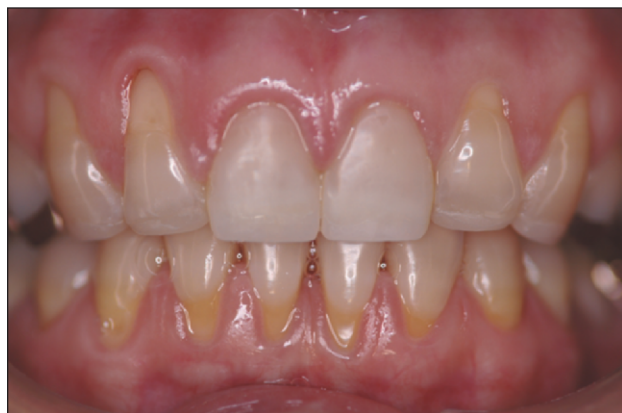
Figure 9. Maxillary incisors were restored with ceramic veneers luted with resin composite cement. Substantial loss at their incisal edges, especially in central incisors, was recovered, as can be seen from this picture taken one year after the original restorations.

is an effective way of protecting the remaining tooth structure and is compatible with patient comfort. In this case, ceramic veneers were selected for maxillary anterior restorations, because of their excellent aesthetic appearance and firm coverage of the sensitive palatal site. Dual-cured resin composite cement, in conjunction with a modern dentin bonding system, was used with the expectation that it would offer promising longevity of restorations and protection of pulp. Since it was apparent that the vertical dimension had decreased in this patient, interocclusal relation needed to be restored in order to obtain sufficient space for ceramic restorations. Resin facing metallic restorations are an alternative choice to all ceramic restorations, but ceramic veneers were chosen as a better way of preserving the remaining tooth structure.

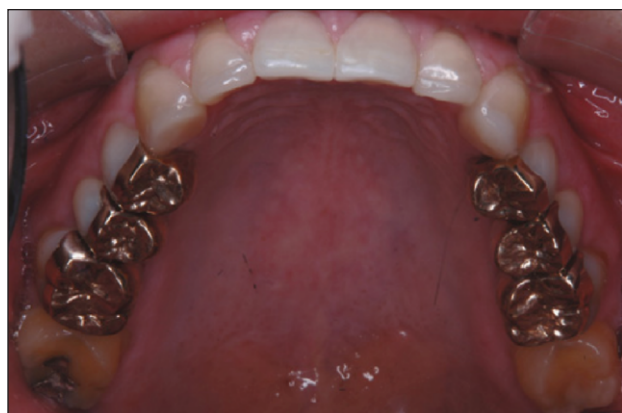
Figure 11. Maxillary occlusal view shown one year after the restorations.

were obtained. Since the patient, who exhibited severe erosion, accompanied by a loss of vertical dimension, sought to achieve the best aesthetic appearance in the maxillary incisors, an intensive course of treatment was undertaken over several months. The treatment also had the secondary benefit of helping to restore her self-esteem. The treatment, which was considered necessary, included the removal of pulpal sensitivity, reconstruction of functional occlusion and extensive prosthetic treatment, including both incisors and molars. Ceramic veneers (IPS Empress 2, Ivoclar Vivadent AG, Fustentum, Liechtenstein) with incisor and palatal coverage were considered for anterior restorations (Figures 8-10), while partial and complete coverage with gold crowns (Casting Gold Type IV, Morita Co, Osaka, Japan) was chosen for posterior restorations (Figures 11-12).

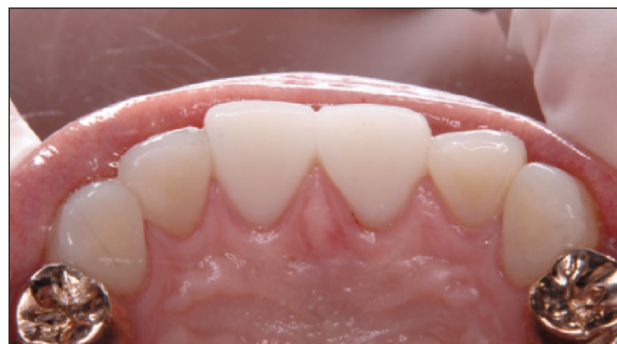
Figure 10. The entire palatal surfaces of the upper incisors were covered.

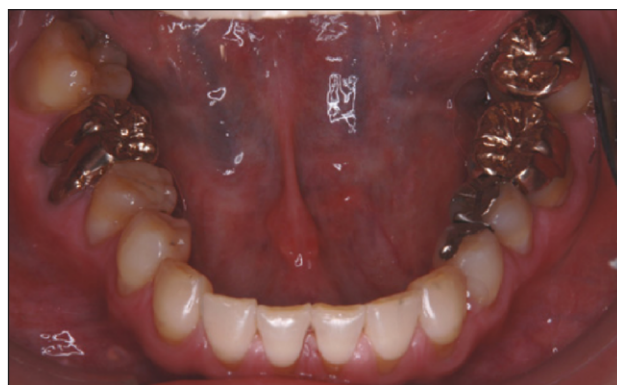
Figure 12. Mandibular occlusal view shown one year after the restorations.
