# Management of Idiopathic Subgingival Amalgam Hypertrophy—The Common Amalgam Overhang

## SUMMARY

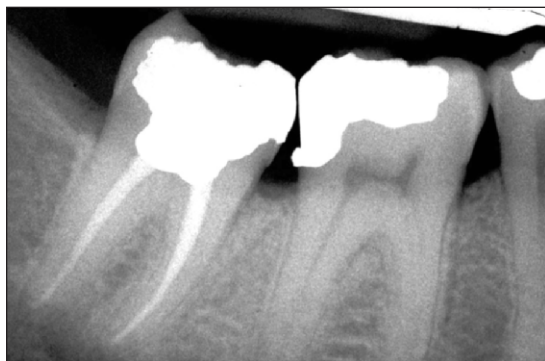
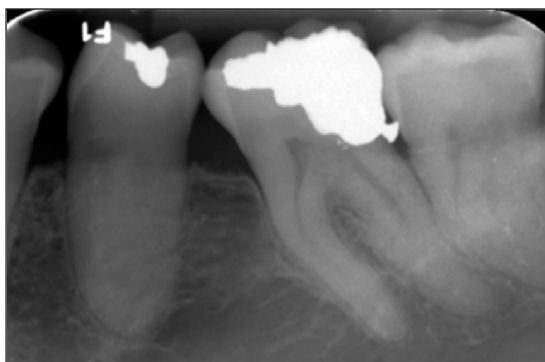
Figure 1a. Preoperative radiographic image on tooth #19 DO.

Figure 1b. Radiographic image of the corrected restoration.

Figure 2a. Preoperative radiographic image of tooth #30 DO.

Figure 2b. Radiographic image of the corrected restoration.

Small and supragingival overhangs can be easily removed (Figures 1a and 1b; Figures 2a and 2b) using a variety of instruments. Periodontal scalers, curets and files can be used to remove the bulk of amalgam overhangs by force via crushing and fragmentation. An instrument, such as a Gracey 204S, is appropriate because of its durable heavy design, which allows for increased leverage. The remaining overhang material can be removed by upward cutting strokes with an amalgam or gold knife and Bard-Parker #12 surgical blade. Manual dexterity and the control of force is of utmost importance in using these instruments, as

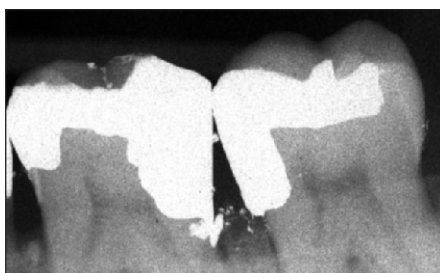
Figure 7a. Preoperative radiographic image of teeth #30 and #31. Deep gingival overhang existed in both the distal portion of #30 and the mesial portion of #31.

Figure 7b. Radiographic image of the corrected restorations.

For large amalgam overhangs, a reciprocating handpiece (KaVo 2061 CHC with a 61LG Head, KaVo America Corporation, Lake Zurich, IL, USA), in conjunction with appropriate diamond files (Proxoshapes, KaVo America Corporation), can achieve the best results (Figures 7a and 7b). However, damage to the adjacent tooth structure and soft tissue can still occur. The clinician must operate the reciprocating files with light pressure and without jamming the interdental space. A sweeping, continuous motion with generous water spray following the contour of the tooth should be used. After removal of the gross overhang, the previous procedures described for medium and small overhangs may have to be repeated to achieve acceptable results. Sometimes, the overhang is too large or inaccessible for all the techniques described and replacement is the only option (Figures 8a and 8b). A list of instruments and their application is summarized in Table 1.

One of the common side effects of amalgam overhang removal is the occurrence of amalgam tattoos (Figure 9). They are due to deposits of metal dusts and debris in the oral soft tissue, which are components of an amalgam filling (Figures 4b, 5b and 7b). One way to minimize the metal dust and debris collection is to use generous water spray during and after the overhang removal procedure. The amalgam tattoo is relatively inert and usually causes no tissue damage.<sup>19</sup> Unfortunately, the discoloration is permanent and the patient has to be informed prior to the overhang removal procedure.

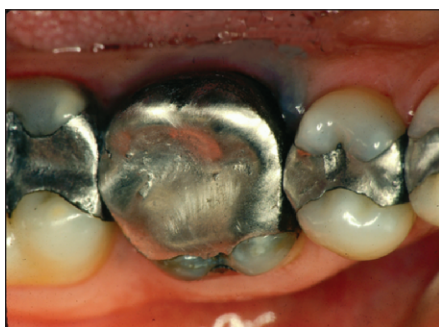
Figure 9. Discoloration of mucosal tissue presented as an amalgam tattoo at the mesio-lingual area of the complex amalgam restoration of tooth #30.
