Alternative Technique for Class V Resin Composite Restorations with Minimum Finishing/ Polishing Procedures

CR Perez

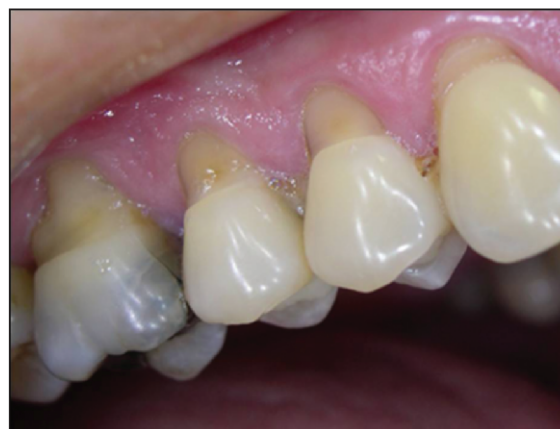
Figure 1. Clinical aspect of NCCL lesions.

This case involves a 32-year-old patient with three NCCL in teeth #2, 3 and 4 (Figure 1). After the patient answered health questions and received an oral examination, it was concluded that the lesions has multiple causes (occlusal factors, abrasion due to incorrect tooth brushing, and possible acid erosion due to the high consumption of cola soft drinks). The lesions were not very sensitive but did prevent good oral hygiene. Since the margins of the cavities extended subgingivally and were not ideal for the fixation of an isolation clamp, the new Class V restorative technique was performed.

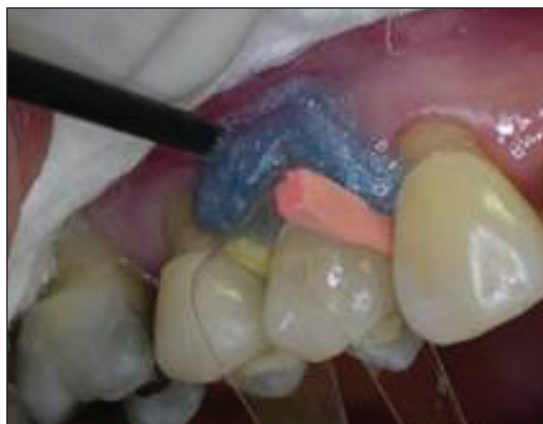
Figure 2. Photocurable gingival barrier placement around the matrix/wedges complex.

The next step is key to the success of this technique: the Mylar matrix positioning and fixation. The Mylar matrix was previously cut to fit the restoration and facilitate the insertion of flowable resin into the cavity. Matrix cutting is not always required. The matrix was inserted into one side of the cavity and fixed into place with a wood wedge. It was then carefully inserted into the gingival sulcus, involving the entire cervical wall of the cavity. The unattached side of the matrix was positioned by inserting another wedge into the opposite side of the cavity. A photocured gingival barrier (TopDam/FGM, Joinville, Santa Catarina, Brazil) was injected around the Mylar matrix in order to stabilize it (Figure 2). This procedure is not difficult to perform but has to be done with precision in order to form a large enough opening between the matrix and tooth to allow the point insertion of the flowable resin. This procedure will also allow the necessary volume of restorative material to be inserted without any excess and adequate penetration between the gingiva and tooth, forming an angle that provides enough aperture to the flowable resin point insertion. Some authors recommend contouring of the gingival aspect of the matrix by stretching the middle gingival portion over the shaft of an explorer to gain a shape consistent with the emergence angle on the cement-enamel junction of the tooth prior to securing the matrix against the tooth.

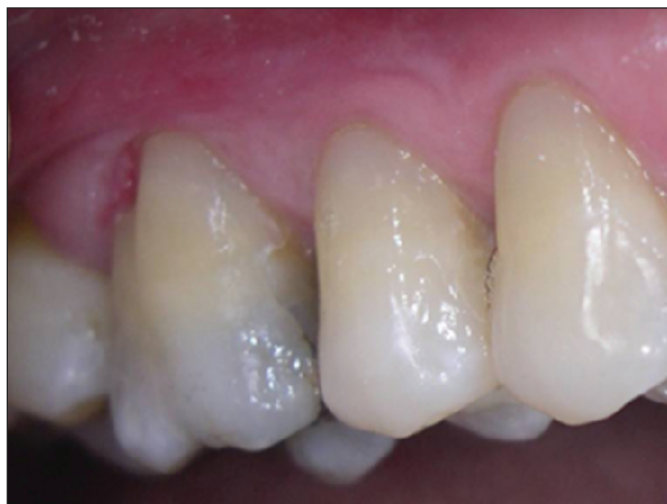
Figure 4. Final aspect of the restorations.

The final aspect of the restorations is seen in Figure 4. No additional finishing or polishing methods were necessary.
