The Effects of Scaling and Root Planing on the Marginal Gap and Microleakage of Indirect Composite Crowns Prepared With Different Finish Lines: An *In Vitro* Study

D Angerame • R Sorrentino • D Cettolin
F Zarone

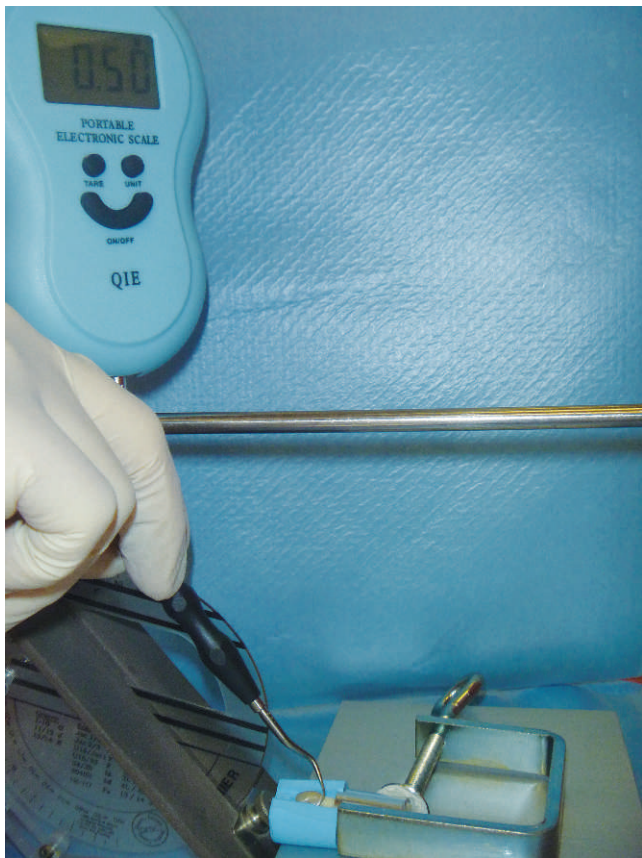
Figure 3. Dynamometric appliance used to standardized the force and the direction of the strokes.

A total of 36 indirect composite restorations (ie, nine per group) were subjected to root surface procedures simulating five years of semestral mechanical supportive periodontal treatment.^{39,43} Each crown surface was scaled and root planed with Gracey curettes 7/8 (Immunity, Hu-Friedy, Chicago, IL, USA) by the same experienced dental hygienist. Forty continuous overlapping strokes were used across the restoration margins with a movement of about 2 mm (ie, from 1 mm apical to 1 mm coronal to the margin) at 15 mm/sec with a force of 5 N. Twenty strokes were made with the tip held parallel, whereas another 20 strokes were made with the tip held diagonal to the longitudinal axis of the teeth; the direction of the strokes was standardized using a goniometer linked to the holder of the specimens. A digital dynamometer was linked to the curettes in order to standardize the force of the strokes; the holder of the dynamometer was linked to a metal ring that could slide around a horizontal metal bar in order to follow the curettes during the instrumentation (Figure 3).

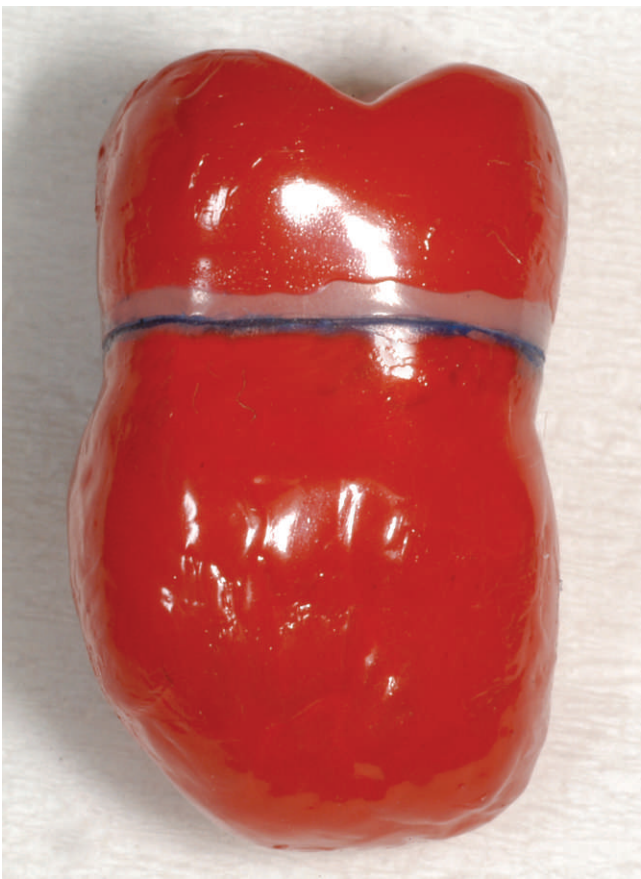
Figure 5. Specimens covering and margin exposure for microleakage test.

Wax and three layers of an isolating varnish were placed 1 mm coronal to the margin of the crowns; the root surfaces were fully covered with the same materials (Figure 5). Afterward, the specimens were immersed in a methylene blue supersaturated solution at room temperature for 10 minutes. The specimens were rinsed with water to remove the remnants of methylene blue, and the isolating materials were removed with a spatula.
