# Conservative Restoration of Worn Mandibular Anterior Teeth Combining Gingival Repositioning and a Template Matricing Technique

HA St Germain Jr • JF Jenkins

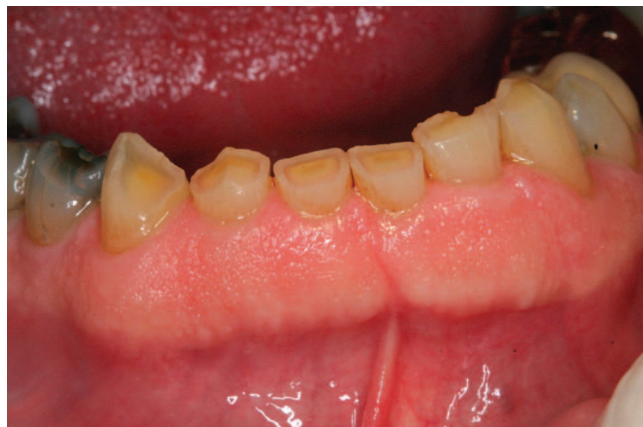
Figure 1. Preoperative condition of worn mandibular anterior teeth.

The extent of the tooth structure loss on the mandibular anterior teeth is depicted in Figure 1, and the two-week healing of the periodontal crown-lengthening surgery is illustrated in Figure 2. Although the crown-lengthening procedure resulted in apical positioning of the gingiva and increased incisogingival length of the incisors, it did not expose the CEJ. The restorative procedures were completed

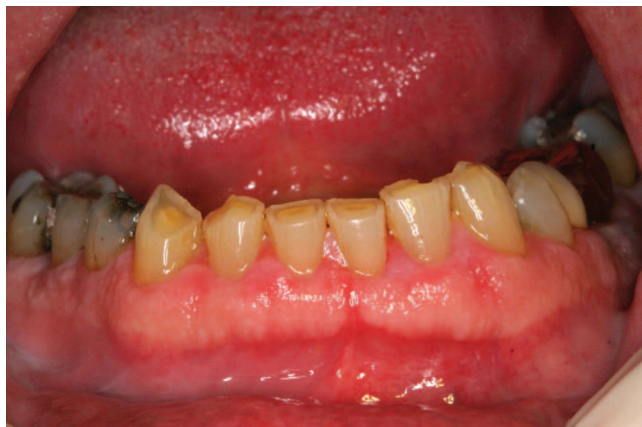
Figure 2. Two-week postoperative healing after crown-lengthening surgery of the mandibular anterior teeth.

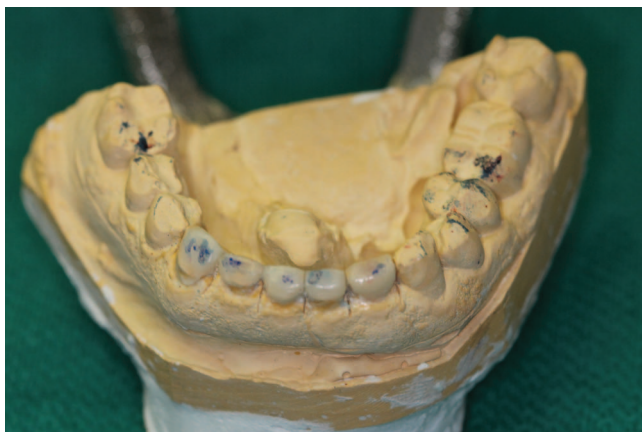
Figure 3. Model with the diagnostic mock-up on the mandibular anterior teeth.

acquired occlusal scheme. There was a risk of perforating through the metal on the maxillary PFM prostheses to the underlying tooth structure or buildup material; however, because the selective grinding was minimal, we were able to avoid perforating the existing restorations. The resin composite mock-up is shown in Figure 3. The OVD was not changed, so the incisal length of the mandibular anterior teeth was limited by the MIP and the patient's anterior guidance.

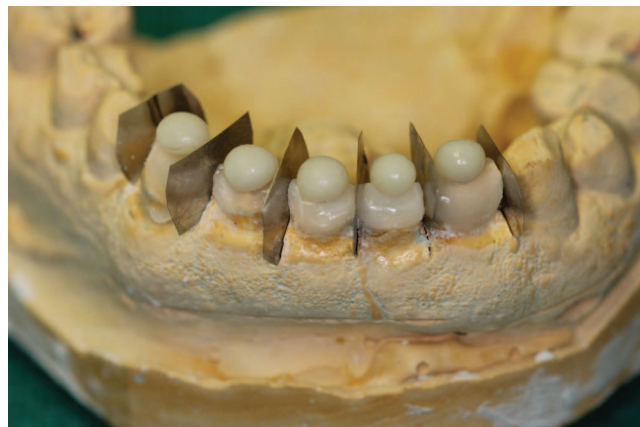
Figure 4. Proximal positioning of the stainless steel matrices and the placement of a round bead on the incisal edge to create a sprue for the resin composite tip.

Figure 4 illustrates the custom template preliminary procedures on the study model after the diagnostic mock-up was completed. Proximal cuts were made with a Ceri-saw (DenMat Holdings, Inc, Lompoc, CA, USA) to open up the interproximal areas on the stone cast. Round beads of resin composite of similar diameter to the tip of the resin composite applicator were placed on top of teeth #23–27, serving as a sprue, and sections of stainless steel (SS) matrix material (0.0015" #1 Tofflemire matrix, Safco Dental Supply, Buffalo Grove, IL, USA) were placed mesially and distally of each tooth being restored to avoid inadvertent placement of resin composite on adjacent teeth.

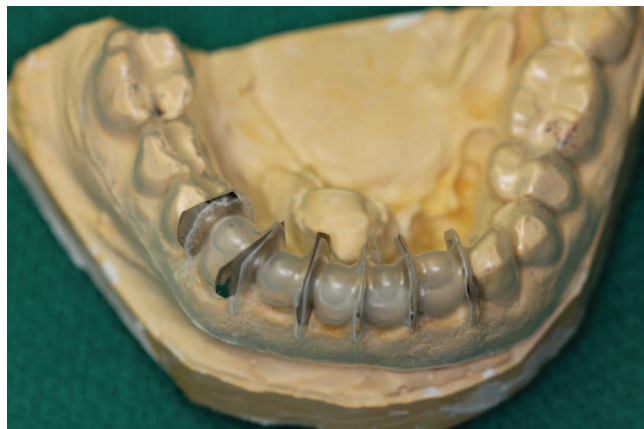
Figure 5. Template seated on the diagnostic cast mock-up with stainless steel matrices in place after opening up the interproximal space on the template with a #25 blade.

a #6 Bard-Parker scalpel (Zahn Dental/Henry Schein, Cookstown, NJ, USA) with a #25 blade to facilitate subsequent placement of the SS matrices back in place when the template is transferred to the mouth. Figure 5 shows the custom template with the SS interproximal matrices in place.<sup>27</sup>

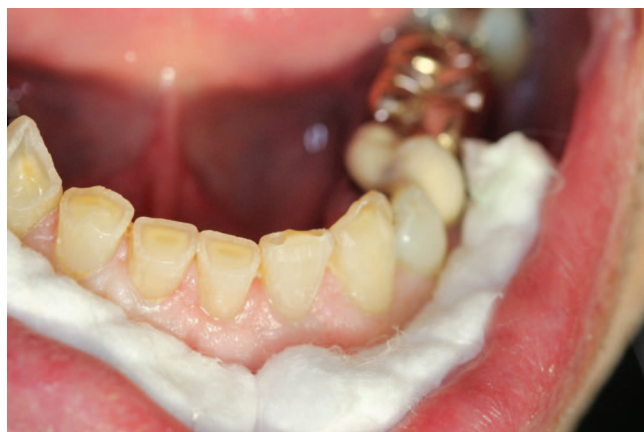
Figure 6. Example of a tooth preparation on the mandibular left lateral incisor illustrating retentive potholes and the peripheral circumferential bevel.

Figure 6 shows the preparation design for teeth #23–27 with two retentive potholes at the incisal edge, 1.0 mm in diameter and 1.0 mm deep, in dentin using a #329 carbide bur (Brasseler USA, Savannah, GA, USA), and the peripheral enamel was prepared with a circumferential 1.0-mm bevel using a #8889 ultra-thin flame diamond (Brasseler USA). Proximal relationships between the mandibular anterior teeth were left as they existed preoperatively.

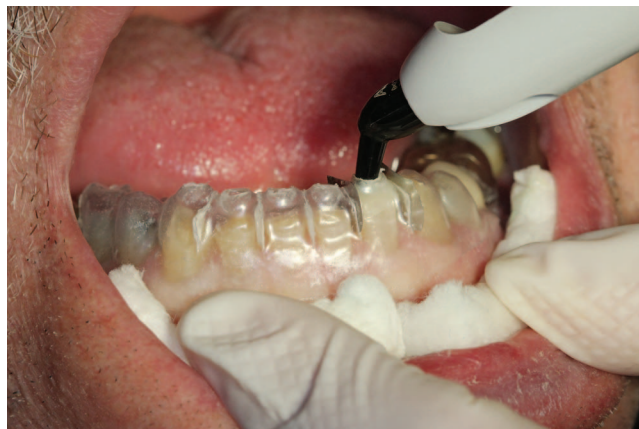
Figure 7. Custom template in place intraorally with interproximal stainless steel matrices and resin composite tip placed in the sprue hole for building up one tooth at a time.

Figure 7 illustrates the interproximal SS matrices in place and the positioning of the resin composite delivery tip for filling the custom template and building up the restoration. The teeth were etched with 35% phosphoric acid, a two-step primer & bonding resin application and followed by restoration with a radiopaque, microhybrid resin composite material. The brand names of the materials used were Ultra-etch, PermaQuick, and Amelogen Plus (Ultradent Products, Inc). The teeth were built up one at a time. Etching and placement of the primer and bonding resin were accomplished before placement of the custom template. The resin composite buildup required only one increment, which was  $\leq 2.0$  mm, so incremental light polymerization was not needed. The resin composite delivery tip was placed close to the surface of the tooth inside the access hole in the custom template. While slowly being with-

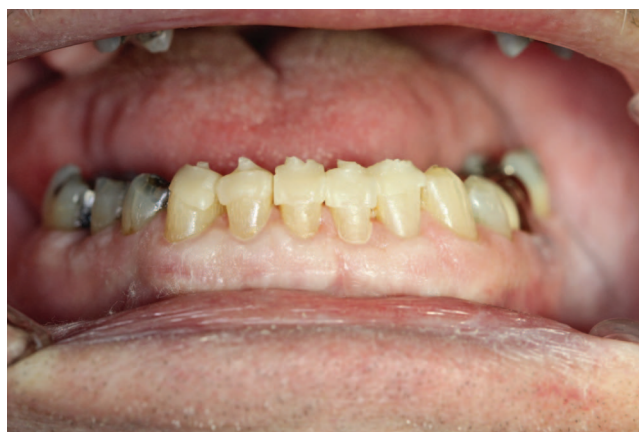
Figure 8. Mandibular anterior teeth with resin composite buildups ready for contouring and polishing.

drawn, pressure was generated to force the resin composite into the template space, resulting in a slight amount of excess composite requiring minimal contouring and finishing. The resin composite sprue served to minimize air voids in the buildup. Figure 8 shows the completed buildups before finishing and polishing. The sprue button on the top of the incisal edge was carefully finished to the predetermined diagnostic mock-up incisal edge configuration, and the proximal embrasures were finished to remove excess composite.

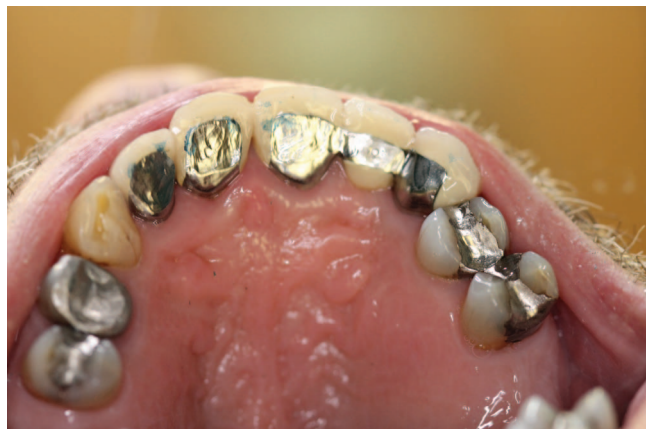
Figure 9. Selective grinding completed prior to final finishing on the lingual metal of the maxillary fixed prostheses.

The patient's occlusal contacts were in harmony with MIP and protrusive guidance with maintenance of the preexisting OVD. Figure 9 illustrates the lingual metal surfaces of the maxillary fixed prostheses

immediately after the selective grinding was accomplished using the occlusal adjustment planning done on the diagnostic cast as a guide. These rough surfaces were subsequently smoothed using rubber abrasives. Since compromises were made in the incisal anatomy on the diagnostic mock-up to minimize increases in OVD, perforation of metal was avoided, and the lingual metal surfaces were conservatively contoured as planned, finished, and polished. Figure 10 shows the final results of the resin composite restorations after finishing, polishing, and checking MIP and anterior guidance contacts and the healthy gingival tissues. A frontal perspective of the patient in MIP is depicted in Figure 11.

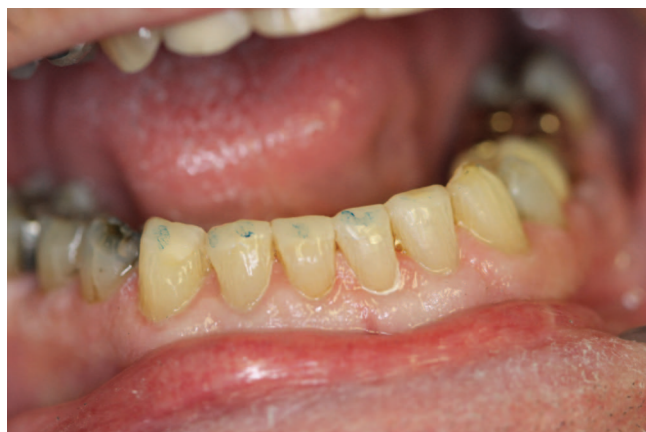
Figure 10. Final occlusal markings on contoured and polished resin composite restorations on the mandibular anterior teeth. Minimal adjustment was necessary, and the resin composite restorations were subsequently polished to a high gloss with abrasive-impregnated rubber points, cups, and disks.

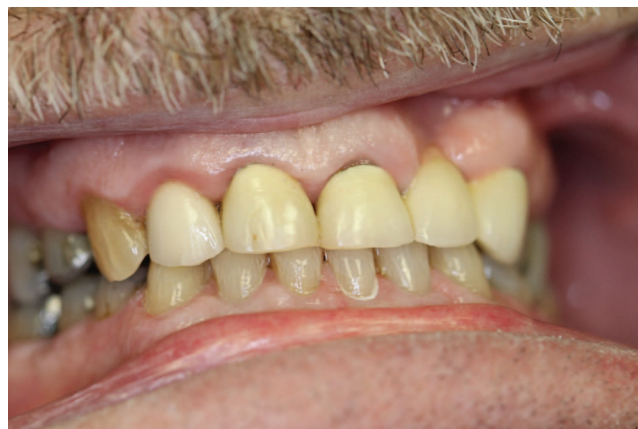
Figure 11. Frontal perspective of the patient in maximum intercuspation position after gingival surgery and resin composite restorations.

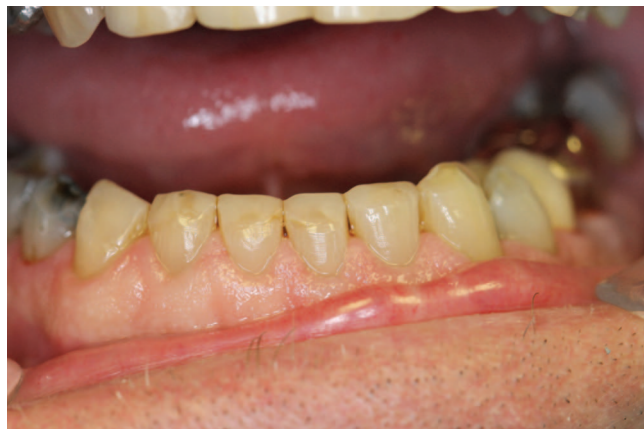
At the two-year recall visit in January 2014, it was observed that the resin composite restoration on tooth #27 had sustained a partial cohesive fracture. The preparation was modified to increase retention,

Figure 12. Three-year post-operative condition of mandibular anterior teeth with resin composite build-ups.

the peripheral bevel was prepared again, and the tooth was subsequently restored to the previously established contour and occlusion on the diagnostic mock-up with resin composite using the original custom template with interproximal matrices. Figure 12 illustrates the condition of the restored mandibular anterior teeth after 3 years. These restorations continue to be retained although there are signs of wear on the resin composite material. The maxillary occlusal splint required no modifications.
