Prosthetic Rehabilitation of a Patient With Gastroesophageal Reflux Disease: Five-Year Follow-up

G Moretto • YM Pupo • ALN Bueno
FO Araujo

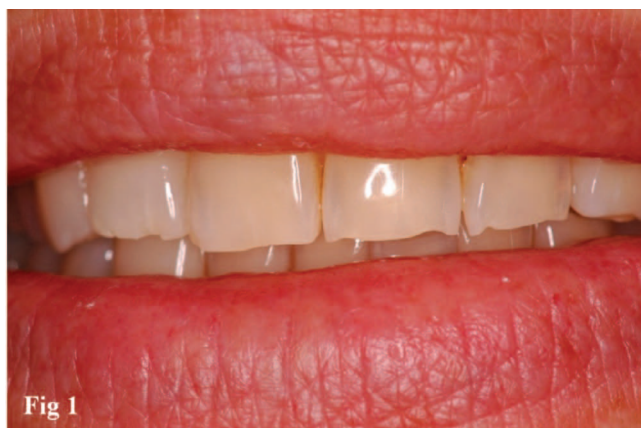
Figure 1. Initial appearance.

A 50-year-old female patient (STC) was admitted to the dental clinic at the University Tuiuti of Parana reporting a diagnosis of GERD a few years ago and dissatisfaction with her smile. Upon clinical examination, there was wear on the incisal and buccal surfaces of her anterior teeth caused by acid erosion. A radiographic examination, study models, and photographic documentation of the clinical case were made (Figures 1 through 3). The patient was referred for medical evaluation, undergoing hiatal hernia surgery.

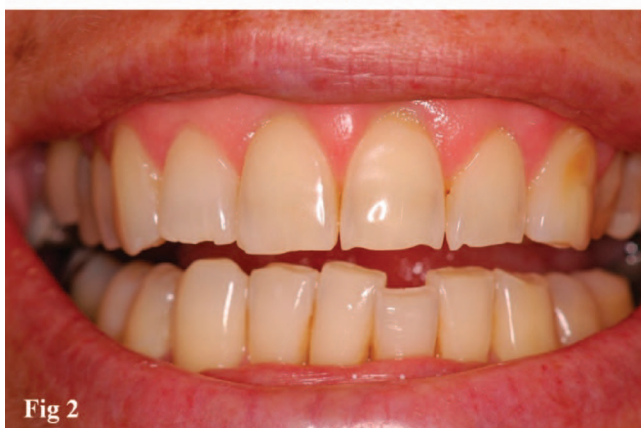
Figure 2. View of incisal and vestibular tooth structure loss.

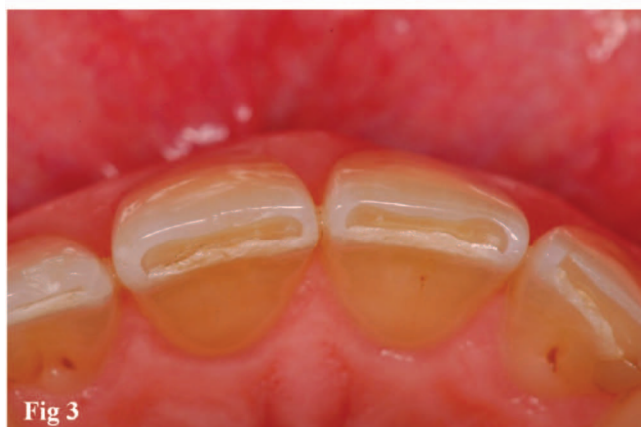
Figure 3. View of initial palatal and incisal wear.

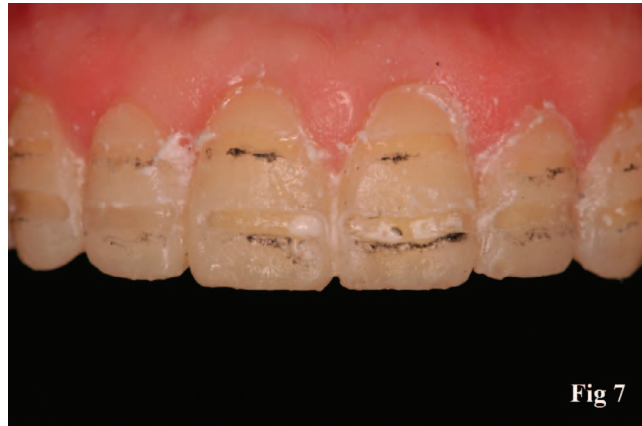
Fig 7

Figure 7. Groove guidance made in the mock-up to a depth that represents the final thickness of the porcelain veneer and allows for the variable thickness of enamel on the eroded surface.

When the patient returned, preparations were performed with care (Figure 7), because the teeth had already lost tooth enamel. Two horizontal grooves were prepared on the buccal surface of the mock-up, with depths varying from 0.5 to 0.7 mm, using a bur with a diamond tip. The grooves were cut to a depth that represents the final thickness of the porcelain veneer and allows for the variable thickness of enamel on the eroded surface. Then, two marks with pencil on the mock-up were drawn to aid in preparing two grooves. The marks were measured with a millimeter probe for evaluation of the depth of the preparations (Figure 8). The mock-up was removed, and the buccal surfaces were reduced using a #4138 diamond bur (Jota, Rüthi, Switzerland), according to the restorative plans (Figure 9). The cervical margin was exposed using #00 retraction cord (Ultrapack, Utradent Products Inc, South Jordan, Utah, USA), and the gingival margins of the porcelain veneers were set at the cervical gingival level. The incisal reduction was set at 1.5 mm using guiding grooves (Figures 10 and 11). This step was performed to facilitate insertion of the veneer and color stratification in this area by the prosthetic technician. The preparation was finished using ultra-fine diamond burs (Jota) and Soft-Lex discs (3M ESPE, St Paul, MN, USA) at low speed.

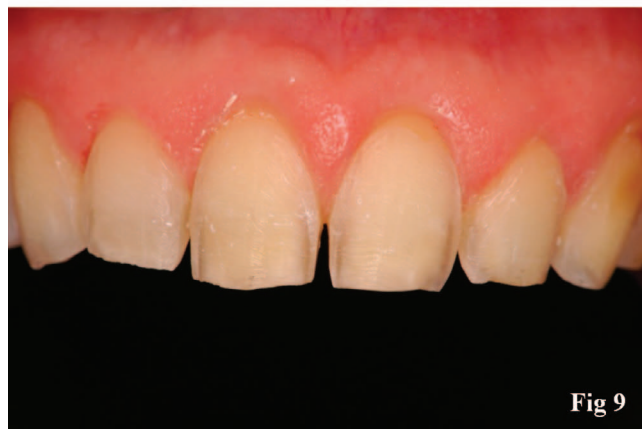
Fig 9

Figure 9. Preparations of the buccal face.

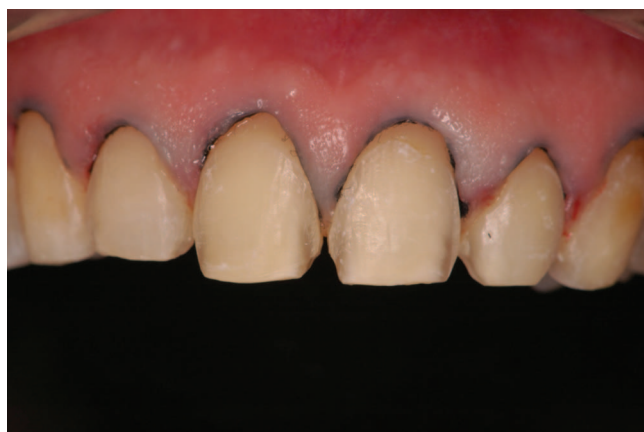
Figure 12. *Finalized and preparations and placement of retraction cord.*

With the preparations completed (Figure 12), an impression of the maxillary arch was made using a condensation silicon impression material (Speedex, Vigodent, Rio de Janeiro, RJ, Brazil). Provisional restorations (Structur 2QM, VOCO GmbH) were cemented after the tooth preparation procedures. Cementation of the relined acrylic resin provisional restorations was done using a noneugenol temporary cement (Provicol, VOCO GmbH).

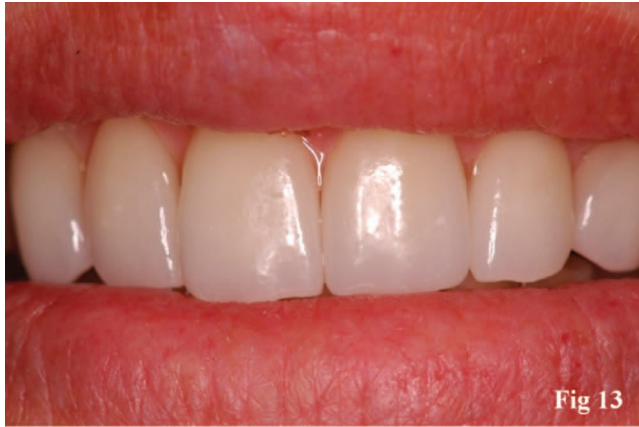
Fig 13

Figure 13. Appearance of the smile after cementation of the veneers.

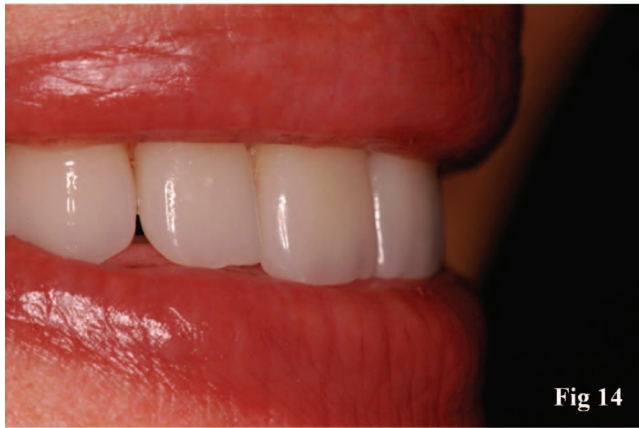
Fig 14

Figure 14. Right side view of the smile after cementing the veneers.

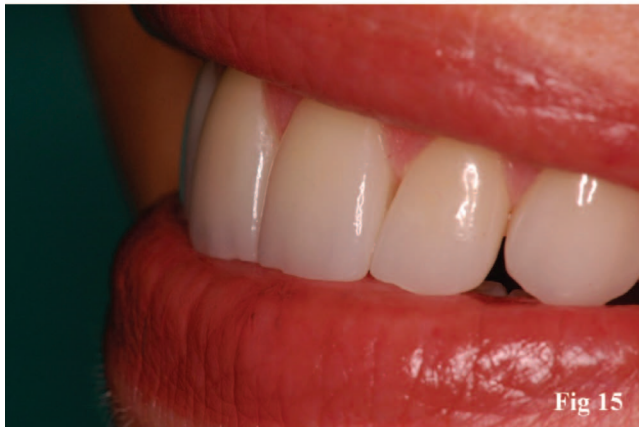
Fig 15

Figure 15. Left side view of the smile after cementing the veneers.

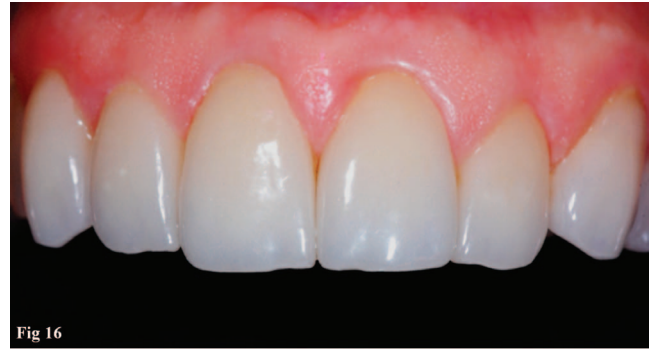
Fig 16

Figure 16. Appearance of the veneers five years after treatment.

Lithium disilicate glass-ceramic (IPS e.max Press, Ivoclar Vivadent, Schaan, Liechtenstein) laminate veneers were fabricated with the heatpress technique. They were veneered with a layering ceramic (IPS e.max Ceram, Ivoclar Vivadent) to improve the appearance of the incisal edge. The internal surfaces of the ceramic laminates were treated with 10% hydrofluoric acid for 20 seconds, followed by washing, drying, and application of a silane coupling agent. The tooth surfaces were cleaned with a pumice and prophy cup in a slow speed handpiece and etched with 37% phosphoric acid for 15 seconds, the adhesive system placed (Scotchbond Multi-Purpose, 3M ESPE) and then light cured for 10 seconds. The resin cement, RelyX ARC (3M ESPE), was used. Excess cement was removed with dental floss and dental explorer prior to curing. The resin cement was light cured on the buccal and palatal surfaces of all teeth for 40 seconds. At the end of treatment, the patient was pleased with the esthetics and function of the restorations (Figures 13 through 15). The clinical case was followed up at five years, analyzing the marginal contour, the presence of cracks, staining, care, and patient satisfaction with the restorations (Figures 16 through 18).

was observed, the veneers were clinically in good condition, and there was no harm to the gingival health. The only detrimental observations with the current clinical case were staining along the gingival margins, although this had no impact on the clinical success. The definitive success of functional and/or esthetic treatments is only achieved when the patient is well informed and motivated to maintain oral health.¹⁸ Excellent home care and periodic control by the dentist is essential to the long-term success of the rehabilitation.¹⁸
