# Surface Properties and Color Stability of Resin-Infiltrated Enamel Lesions

X Zhao • Y-F Ren

Resin infiltration increases surface hardness of white spot lesions and remains stable under thermocycling challenges, but its surface polish and color stability may be of concern when used in the esthetic zone.

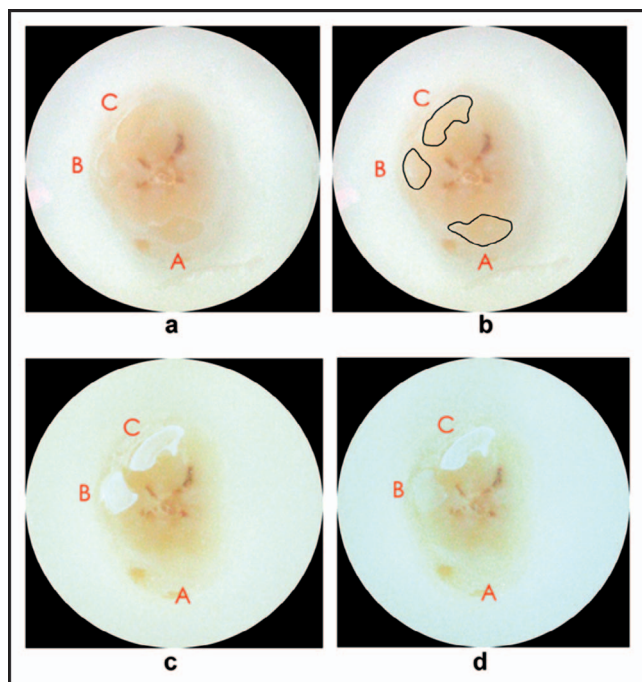
Figure 1. Sample preparation. (a): Occlusal surface of human third molars were embedded in epoxy resin and ground flat to expose three areas (A, B, and C) of at least 2 mm × 2 mm enamel. (b): The exposed enamel areas were typically the two buccal cusps and one lingual cusp of the molar crown. (c): Two separate white spot lesions (A and B) were created. (d): One white spot lesion B was treated with the ICON infiltration resin and one lesion was untreated.

The artificial caries model prepared this way has two separate artificial white spot lesions on the same specimen and one sound enamel area as internal control (Figure 1c). The white spot lesion was identified as an opaque and chalky white area on the enamel surface in contrast to the semi-translucent sound enamel.<sup>22</sup> Each specimen was inspected visually to ensure that the white spot lesions were successfully created on the enamel surfaces.

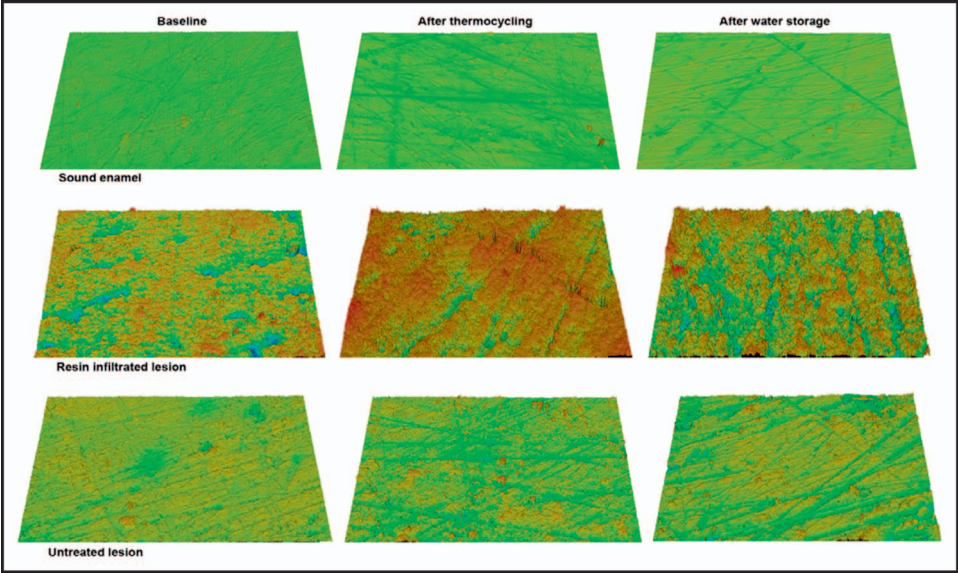
Figure 2. Three-dimensional laser scanning images of sound enamel (top row), resin-infiltrated lesions (middle row), and untreated lesions (bottom row) at baseline (left column), after thermocycling (center column), and after water storage (right column). Surface roughness of resin-infiltrated lesions are greater than sound enamel and untreated lesions and further increased after thermocycling and water storage.

Representative 3D laser scanning images of sound enamel, resin-infiltrated lesions, and untreated lesions are shown in Figure 2. Surface roughness data before and after thermocycling or water storage are listed in Tables 1 and 2. Before aging challenges, the surface roughness of the untreated enamel lesions was greater than that of the sound enamel but less than that of resin-infiltrated lesions ( $p < 0.01$ ; Figure 2; Tables 1 and 2), indicating resin infiltration increased the surface roughness of the enamel lesions. Thermocycling and water storage caused a further increase in surface roughness of the resin-infiltrated surfaces ( $p < 0.01$ ) but did not have a significant impact on the sound enamel and untreated lesion surfaces ( $p > 0.05$ ; Figure 2; Tables 1 and 2). The average surface roughness (Sa) of the resin-infiltrated surface increased from  $0.373 \mu\text{m}$  to  $0.621$

μm after thermocycling for 180 hours. Water storage had a similar effect on the resin-infiltrated surfaces but was smaller in magnitude (from 0.317 μm to 0.472 μm on average).

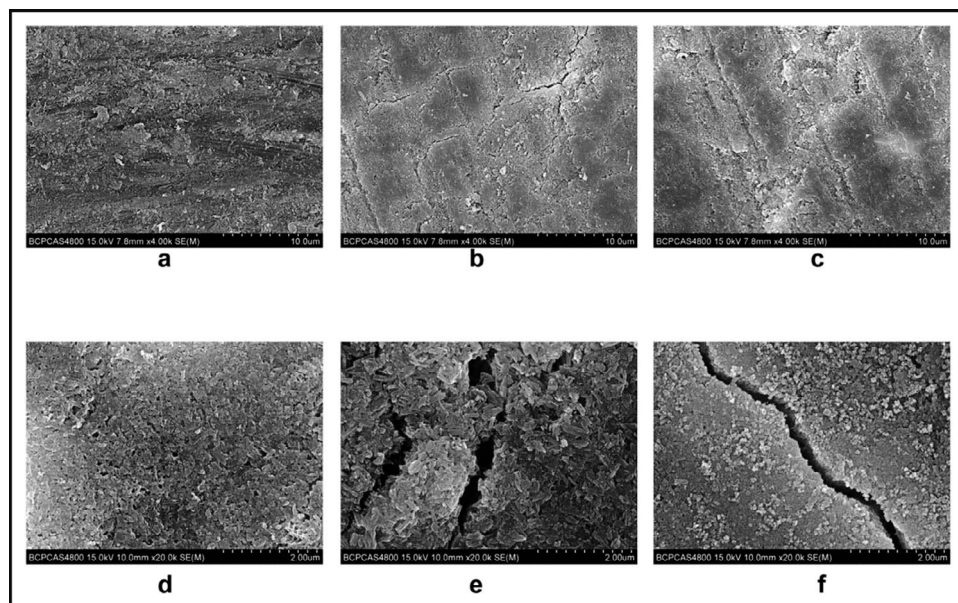
Figure 3. Scanning electron microscopy images of resin-infiltrated lesions. Top row, at 4000 $\times$ : (a): immediately after resin infiltration; (b): after thermocycling; (c): after water storage. Bottom row, at 20,000 $\times$ : (d): immediately after resin infiltration; e: microfissures after thermocycling; f: microcracks after thermocycling.

As shown in Figure 3, resin-infiltrated surfaces were largely intact and uniform before aging challenges (Figure 3a). Surface microcracks and microfissures appeared on resin-infiltrated lesions following thermocycling challenges (Figure 3b). Minor changes could also be observed following water storage but were much less distinct than those after thermocycling (Figure 3c). At high magnification (20,000×), hydroxyapatite crystals were shown to be embedded in the resin matrix to form a relatively uniform and intact surface (Figure 3d). After aging challenges, microfissures and microcracks could be observed on

the surfaces, especially after thermocycling (Figure 3e,f).
