Restoration of Severely Compromised Teeth With Modern Operative Techniques

This case report illustrates how to restore severely compromised teeth with direct composite restorations. The size of the restorations presented is often considered by dentists as being a contraindication for direct composites. Hence, the technique is explained step by step, addressing the crucial points.

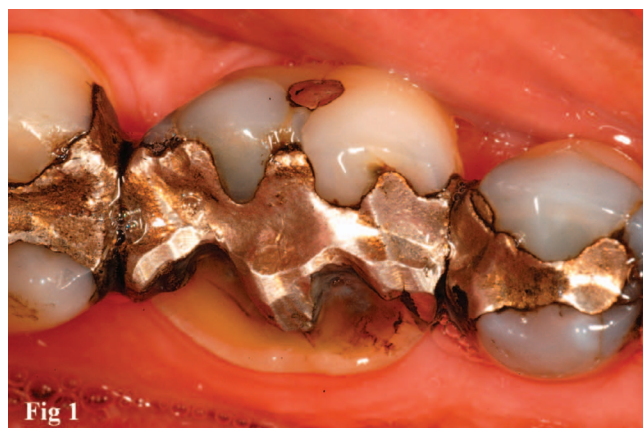
A 47-year-old male patient presented himself with an insufficient restoration on a first lower molar, displaying a fractured lingual cavity wall and multiple cracks in the buccal wall (Figure 1). The adjacent teeth were restored with old amalgam restorations that showed wear and small cracks in the restoration surfaces. However, these teeth were free of secondary caries, and the restorations were functionally intact.

Figure 1. Initial situation: The lingual cavity wall of a lower first molar was fractured. The buccal cusps displayed multiple cracks. The adjacent teeth showed old amalgam restorations with wear and small cracks in the restoration surfaces and marginal staining. However, these teeth were free of secondary caries and the restorations were functionally intact.

It was decided to replace the defective amalgam restoration on the first molar by a direct composite restoration and to keep monitoring the restorations on the adjacent teeth.

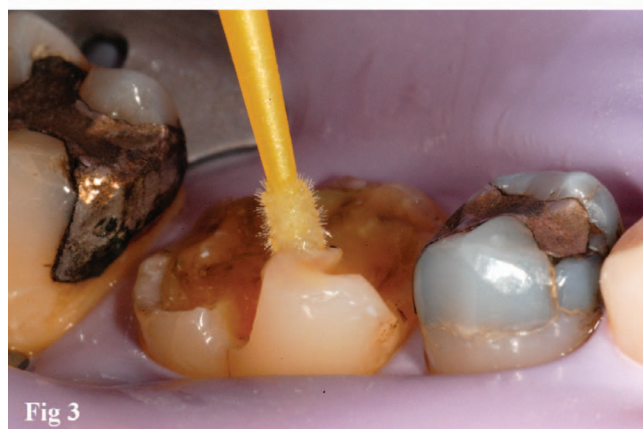
Figure 3. The adhesive protocol included a selective enamel etching for 30 seconds and the application of a two-bottle self-etch adhesive. (AdheSE, Ivoclar Vivadent, Schaan, Liechtenstein).

The preparation was followed by selective enamel etching for 30 seconds and the application of a two-step self-etch adhesive (Figure 3).¹⁵ A sectional matrix was applied and the tooth was built up with six increments of a sculptable bulk-fill material (Figures 4-6). Each increment was light cured with a broad spectrum LED curing light (Bluephase G2, Ivoclar Vivadent, Schaan, Liechtenstein) for 20 seconds at 1200 mW/cm².

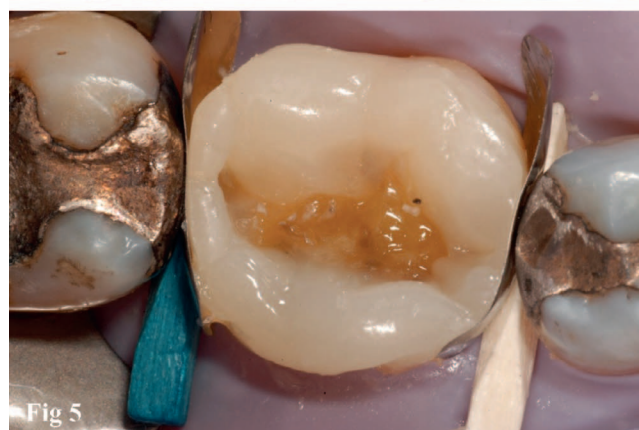
Figure 5. Third and fourth increment built up the buccal and lingual cavity walls.

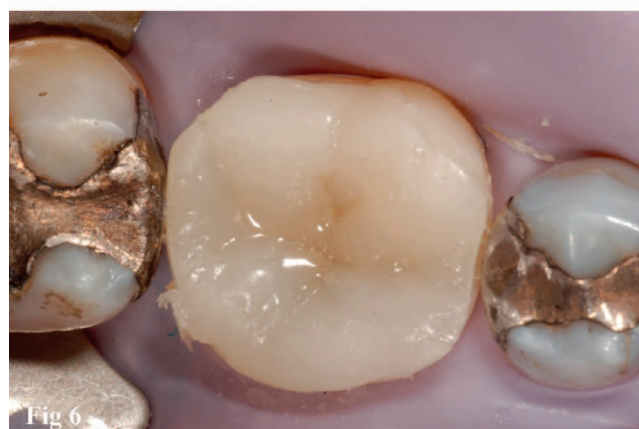
Figure 6. The last two increments finished the occlusal part of the restoration.

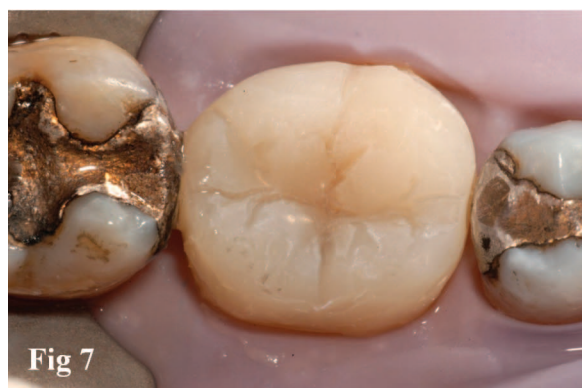
Fig 7

Figure 7. Fine-grit diamonds and flexible polishing discs were used to adjust the shape of the restoration.

After the layering, the occlusion was adjusted and the restoration polished (Figures 7-9).

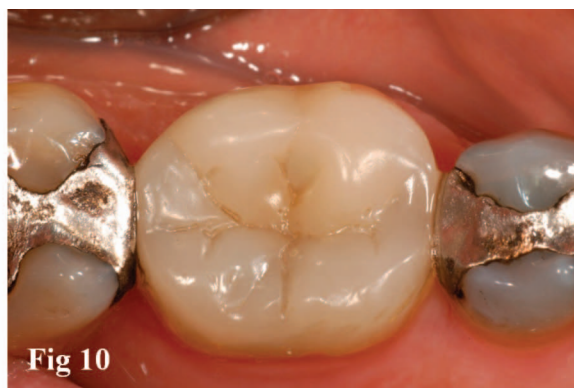
Fig 10

Figure 10. Situation three years postoperative. The restoration looked virtually unchanged. The adjacent old amalgam restorations were still in service.

At the three-year recall (Figure 10), the restoration appeared to be virtually unchanged. The adjacent amalgam restorations were still in service. However, shortly after, the mesial wall of the adjacent premolar fractured (Figure 11), and the restoration was replaced again by a bulk-fill restoration including both cusps (Figure 12).

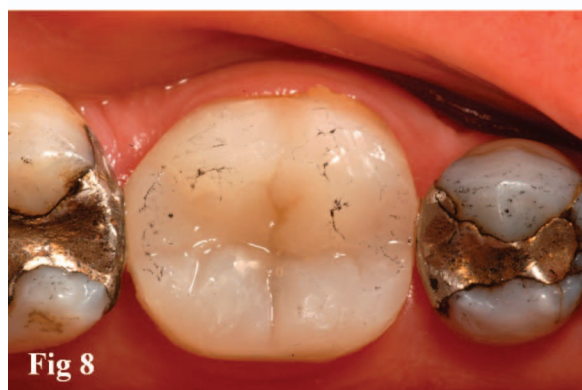
Fig 8

Figure 8. Situation after adjusting the occlusion.

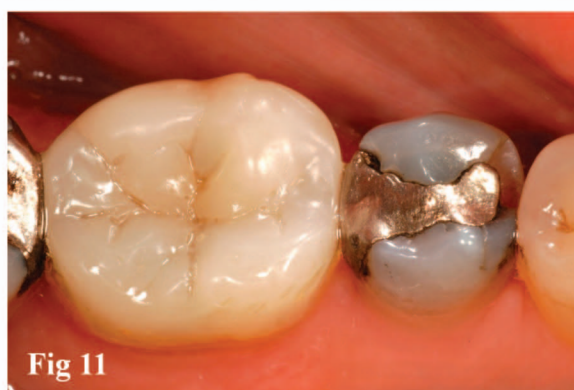
Fig 11

Figure 11. Shortly after, the mesial cavity wall of the adjacent premolar fractured.

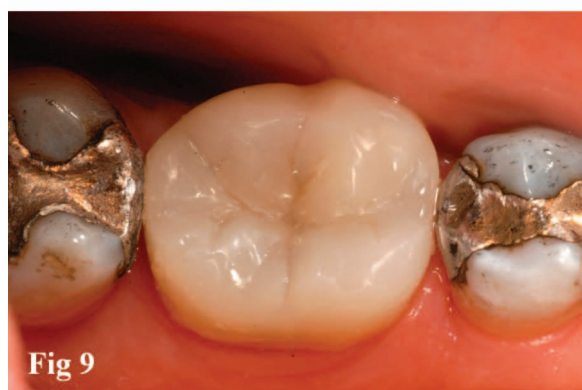
Fig 9

Figure 9. Finished restoration.

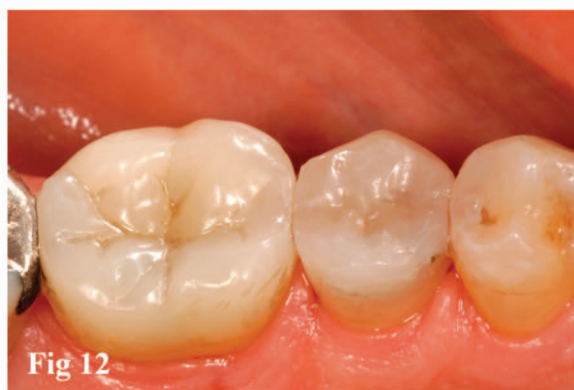
Fig 12

Figure 12. Situation after replacement of the old amalgam restoration with a bulk-fill composite-restoration including the buccal and lingual cusps of the premolar.

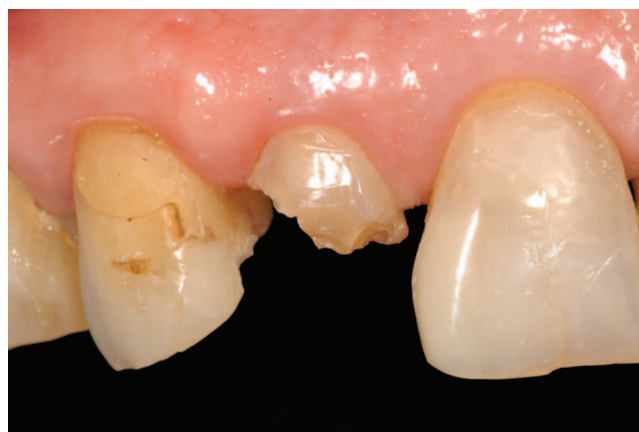
Figure 13. Initial situation.

A 69-year-old female patient came to the clinic with a fractured upper right lateral incisor (Figure 13). The clinical records showed that the patient only saw a dentist erratically, when a restoration fractured or she suffered from dental pain. Her oral hygiene was moderate, and several old restorations showed signs of wear and marginal staining or disintegration; however, no active carious lesions were present.

The fractured lateral was free of caries and vital. The patient asked for a cost-effective, functional solution to the problem. The stained margins on the other anterior teeth were of no esthetic concern to the patient.

It was decided to restore the tooth with a direct composite buildup at the same appointment.

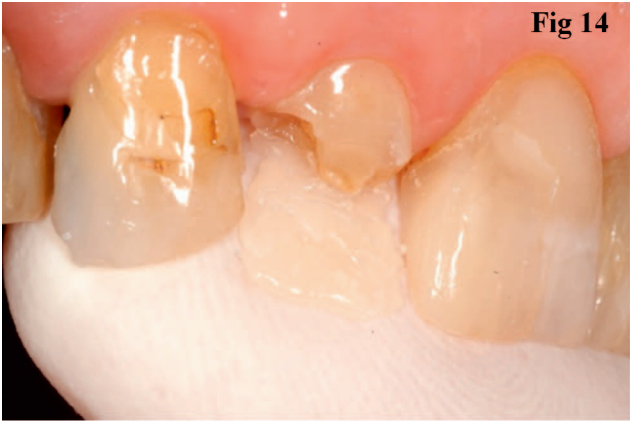
Figure 14. Finger-tip technique: The finger serves as an oral matrix, allowing to easily build up the oral wall. For this first layer of composite, an enamel color must be chosen (Empress Direct, enamel A4, Ivoclar Vivadent, Schaan, Liechtenstein). The layer should be kept as thin as possible (<1 mm). When done right, the finger-tip technique allows excess-free layering and brings the incisal edge into the right position. This way, later adjustments on the oral aspect of the restorations are minimized.

When no silicone key is available, the easiest way of building up an anterior tooth is the “finger-tip technique,” where the index finger is used as an oral matrix on which to adapt the composite (Figure 14).^{21,22} However, it has to be kept in mind that gloves do not prevent the penetration of dental monomers.^{23,24} Hence, touching the uncured adhesive and composite can lead to direct skin contact with the monomers. Research has shown that the prevalence of allergic reactions of dental staff to

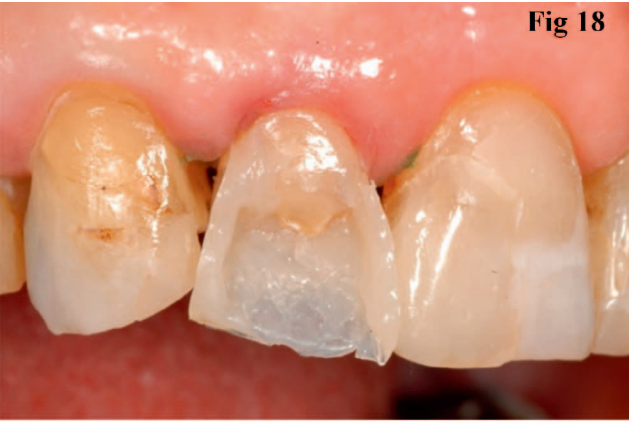
Figure 15. The polymerized first layer.

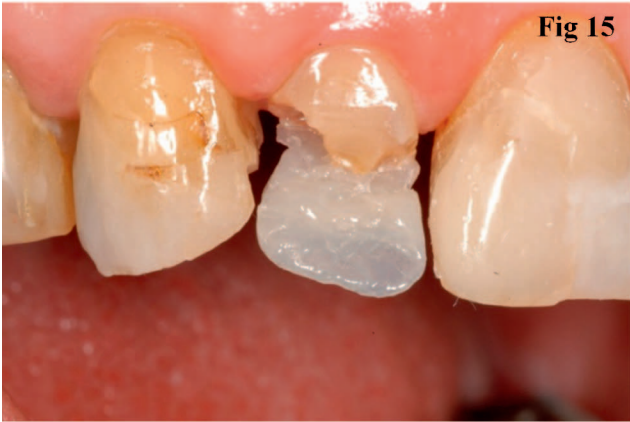
Figure 16. After the first layer was polymerized, a matrix was wrapped around and a wedge was placed. The finger then tightly adapted the matrix to the oral aspect of the first layer.

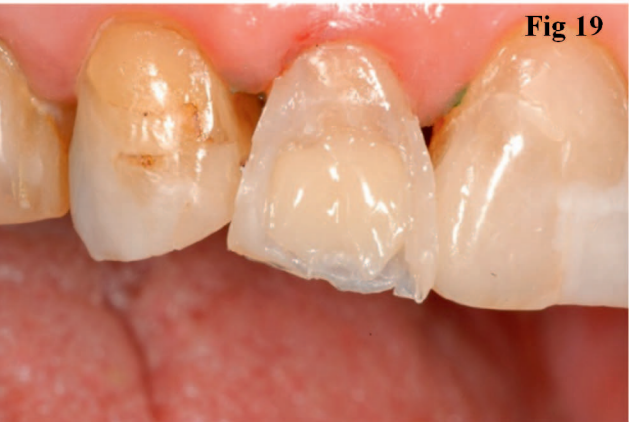
Figure 17. The mesial increment was placed, again using an enamel shade.

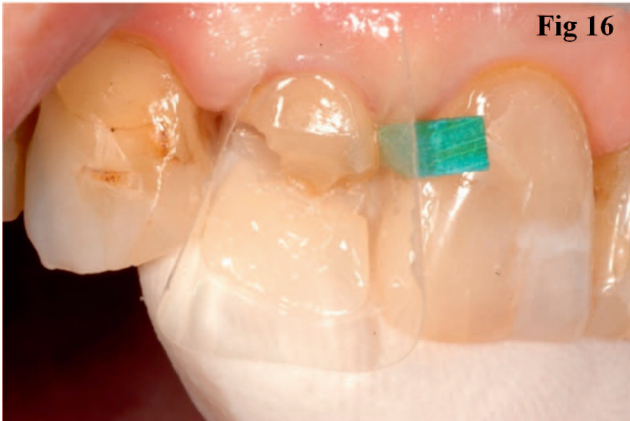
Figure 18. After repeating this technique likewise for the distal interproximal increment, the matrix and the wedges were removed.

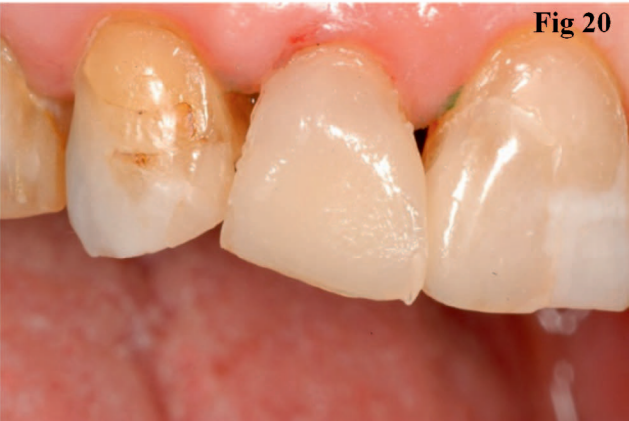
Figure 19. The next step was the application of a dentin shade. This layer is decisive for the final translucency of the restorations. As with natural dentin, composite dentin shades are more opaque than enamel shades. Hence, the thicker the dentin layer that is placed, the more opaque the restoration will be. At the same time, lightness of the restoration will be increased because the opaque dentin shade will optically block out the dark background (the oral cavity) and reflect more incoming light. The key to success in anterior restorations is matching translucency. As a general guideline, for older patients, lower amounts of dentin shade are used because natural teeth become more translucent with age.

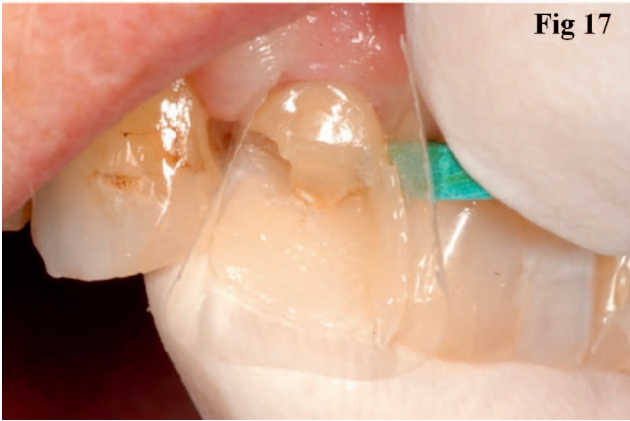
Figure 20. Finally, the oral aspect was covered with a layer of enamel shade.

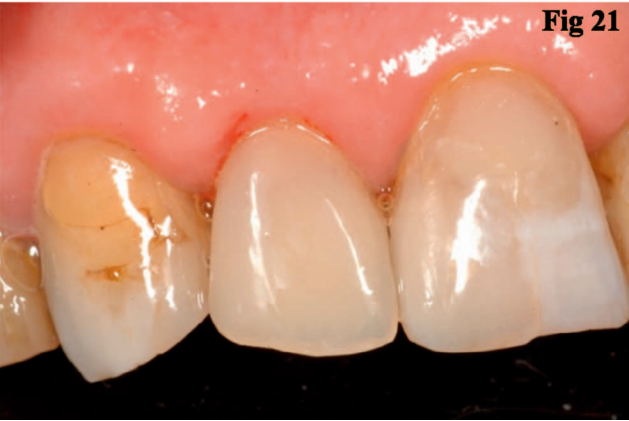
Fig 22

Figure 22. Final situation, one week postoperative. The restoration had a natural appearance, displaying an incisal translucency and a halo effect.

One week postoperative (Figure 22) and at the one-year recall, the restoration showed excellent stability and a harmonic integration (Figure 23).

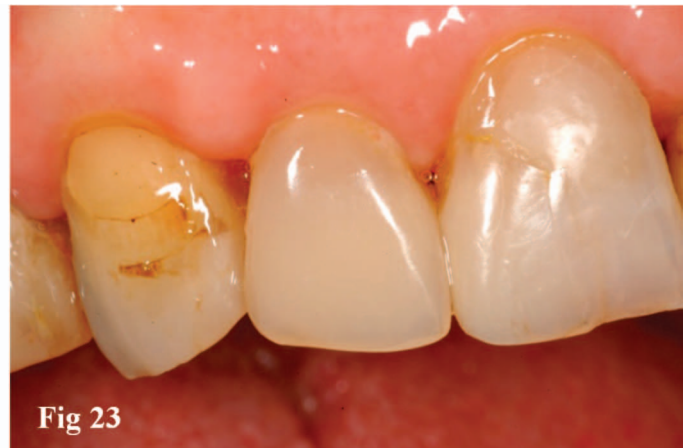
Fig 23

Figure 23. One-year recall: The restoration showed excellent physical and optical stability. The stained restorations on the adjacent teeth were still in place and functional.
