Minimally Invasive Adhesive Rehabilitation for a Patient With Tooth Erosion: Seven-year Follow-up

Clinical Relevance

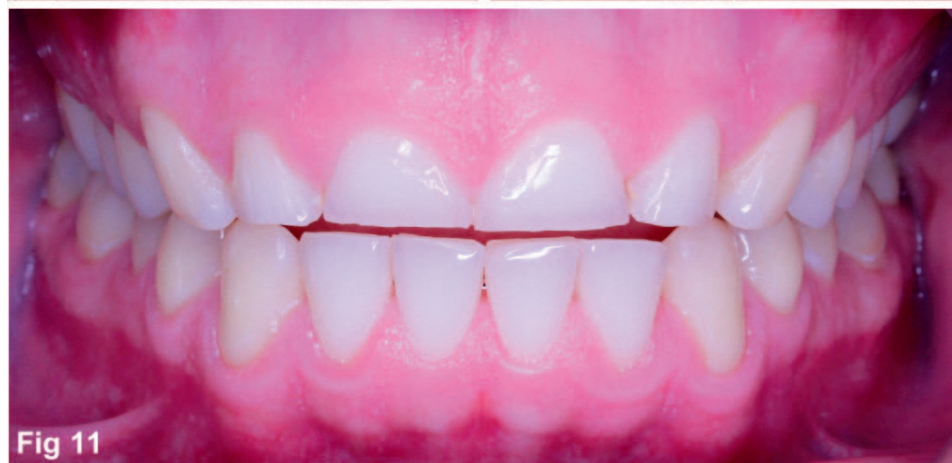
Figure 11. Aspect of the maxillary anterior teeth after reestablishing VDO. VDO, vertical dimension of occlusion.

After restoring the posterior teeth, the reestablished VDO (Figure 11) was tested for one month to allow for the detection of any possible nonadaptation to the new VDO and occlusion before delivering the anterior restorations. The patient maintained an anterior open bite during this phase and related that he was very comfortable with the new occlusion. No major modifications were required for the posterior composite restorations.

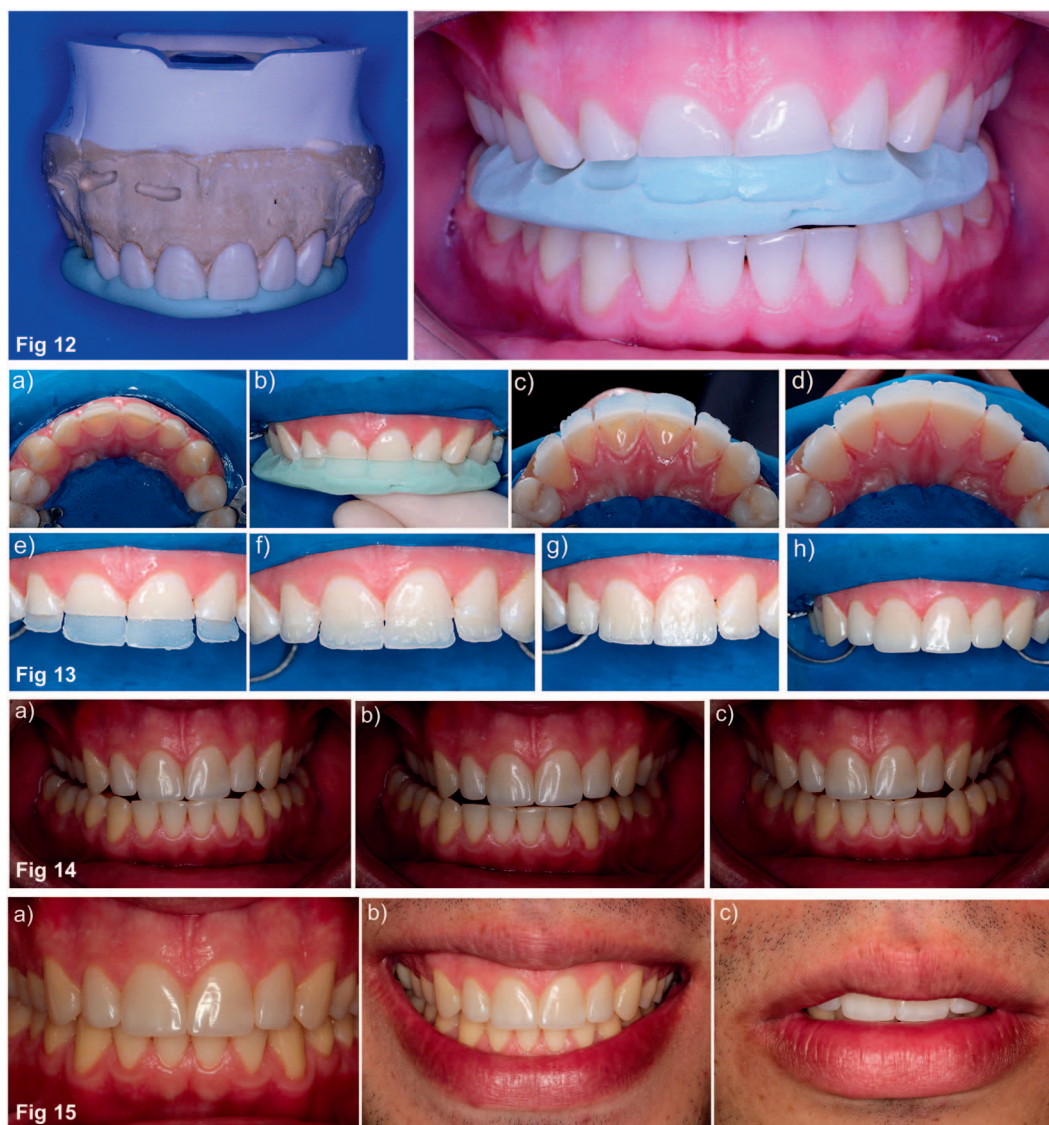
Figure 12. Planning the anterior restorations. (a): Wax-up. (b): Silicon matrix in position.

Figure 13. Anterior restorations. (a): Teeth after isolation. (b): Placement of the first resin increments in the silicon matrix and light curing. (c): Reconstruction of the palatal face. (d and e): Palatal reconstruction with enamel resin in occlusal and frontal view. (f): Insertion of the dentin resin. (g): Insertion of translucent resin in the incisal third. (h): Immediate aspect of the restoration after insertion of the enamel composite.

Figure 14. Occlusal adjustments of the anterior restorations: lateral extrusive (a and b) and protrusive (b) movements.

Figure 15. Aspect of the restorations after polishing. (a): Intraoral view. (b): Smile view. (c): Lips at rest.

and a silicone matrix of the anterior teeth was obtained for use as a guide to construct the palatal surface of the restorations and to establish the correct height (Figure 12). The restorative procedures were performed under isolation using a rubber dam stabilized with clamps on the second premolars. The anterior teeth were prepared using 35% phosphoric acid for conditioning the enamel and dentin surfaces as previously described. The adhesive was placed, air-dried, and photoactivated for 20 seconds. The enamel resin was inserted in the silicone matrix in the region corresponding to the palatal enamel. The matrix was then positioned on the teeth and photoactivated. The palatal surface of each tooth was used as the basis for the other increments of composite resin (color GE2, Enamel Plus HRI, Micerium S.P.A). The lateral and central incisors were built using composite resin increments to

reproduce dentin using color A3 for the middle third and color A2 for the incisal third (Four Seasons, Ivoclar Vivadent). A small increment of translucent resin was placed on the incisal third to reproduce the characteristics of this region (Clear, Four Seasons, Ivoclar Vivadent). Finally, an enamel composite resin (Estelite Sigma, Tokuyama Dental, Encinitas, CA, USA) in color A2 at the middle and color A1 at the incisal third was used to construct the enamel surface. For the canines, color A3 resin was used for dentin (Four Seasons, Ivoclar Vivadent) and for the vestibular enamel (Estelite Sigma, Tokuyama Dental) (Figure 13).

Following the restorations, occlusal adjustment was performed, verifying contacts in protrusive and lateral excursive movements of the maxilla and mandible (Figure 14). Finishing and polishing of the restorations was performed using silicon rubber (Enhance, Dentsply), abrasives disks (3M ESPE), and felt disks (FlexiBuff, São Paulo, Brazil). Strips of sandpaper were used for interproximal polishing (3M ESPE). The final occlusal relationship was satisfactory. The patient's smile was immediately changed in tooth size and shape, giving him an appearance in agreement with his age and gender since he displayed his teeth even with his lip at rest (Figure 15). To maintain the restorations and to

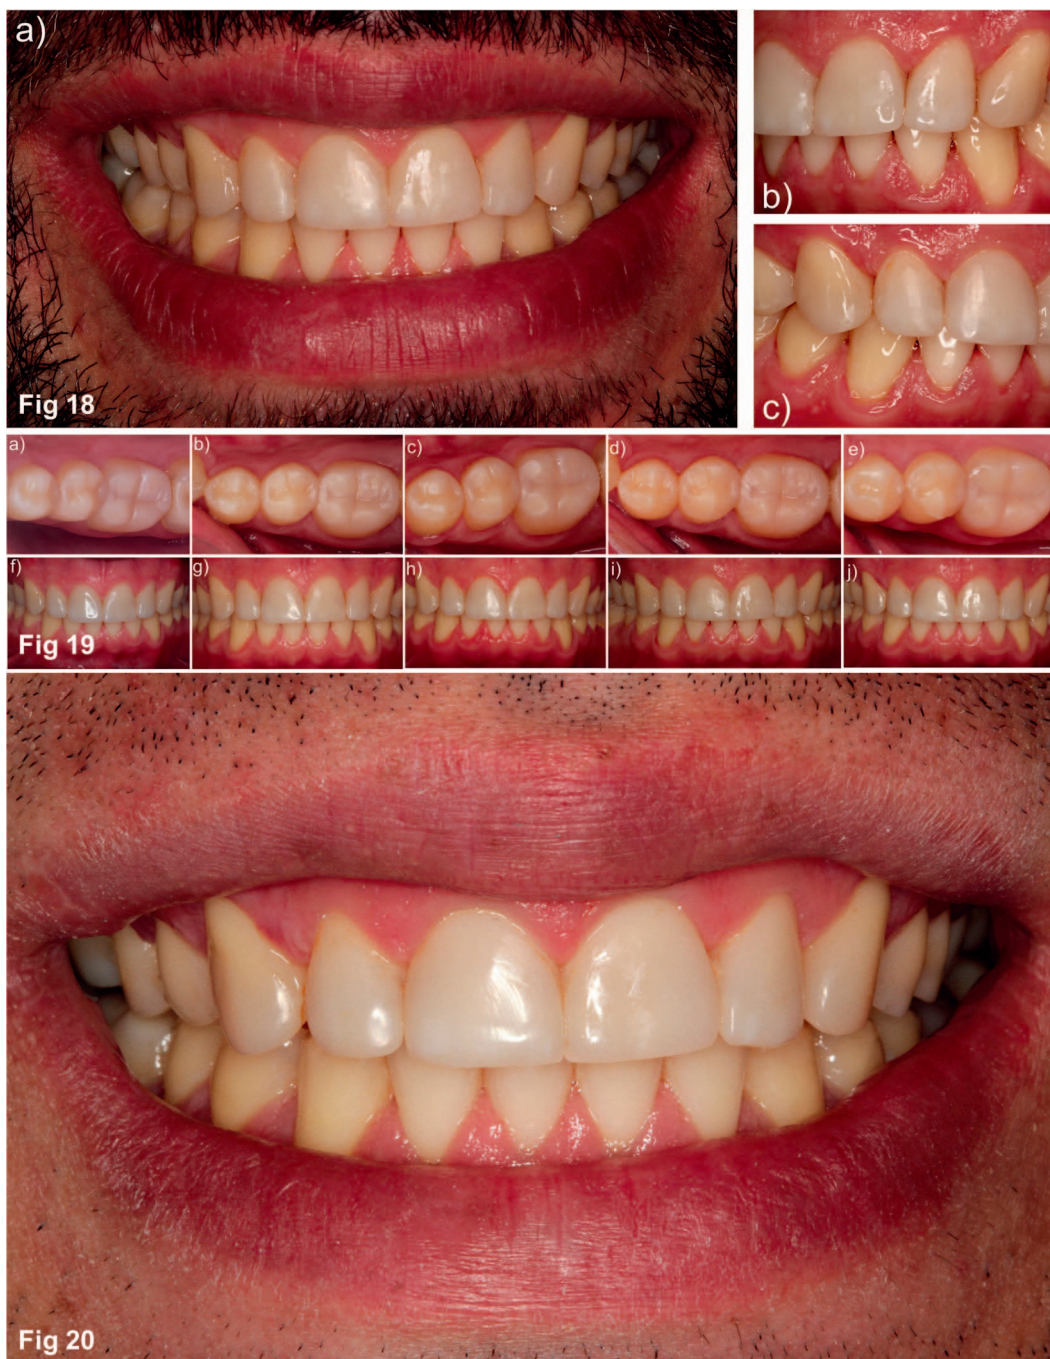
Figure 18. Esthetic appearance of anterior teeth after six years: smile (a) and intraoral (b and c) views.

Figure 19. Intraoral view of the restorations during follow-up. (a and f): Immediate. (b and g): After 12 months. (c and h): After three years. (d and i): After six years. (e and j): After seven years.

Figure 20. Esthetic appearance of patient's smile after seven years.

As with Attin and others,²⁰ this case report evaluated the longevity of the restorations clinically and by using SEM analysis. The follow-up at six years represented by the clinical evaluation showed the clinical maintenance of the restorations over time (Figure 17). On the other hand, the SEM evaluation up to 12 months demonstrated the stability of the restorations in relation to anatomical form and marginal adaptation, especially for the canines and molars, since there were no visible wear facets or marginal maladjustments.
