# Adapted Three-step Restorative Technique: Recovering Dental Substrate Compromised by Complex Erosive Wear in a Young Patient

This article presents the dental restoration of a young female patient complaining of erosive dental wear using a three-step restorative technique, an alternative approach with some novel adjustments.

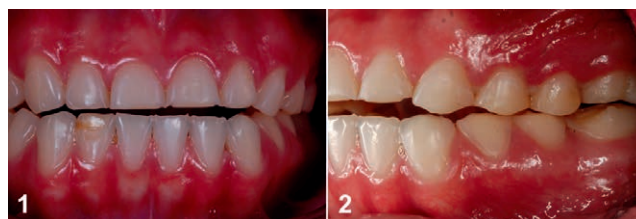
Figure 1. Compromised dental wear of a 16-year-old patient as a consequence of dental erosion associated with bruxism. Intraoral view highlighting incisal compromise and loss of shiny aspect.

Figure 2. Lateral view indicating intense wear and loss of vertical dimension of the left side.

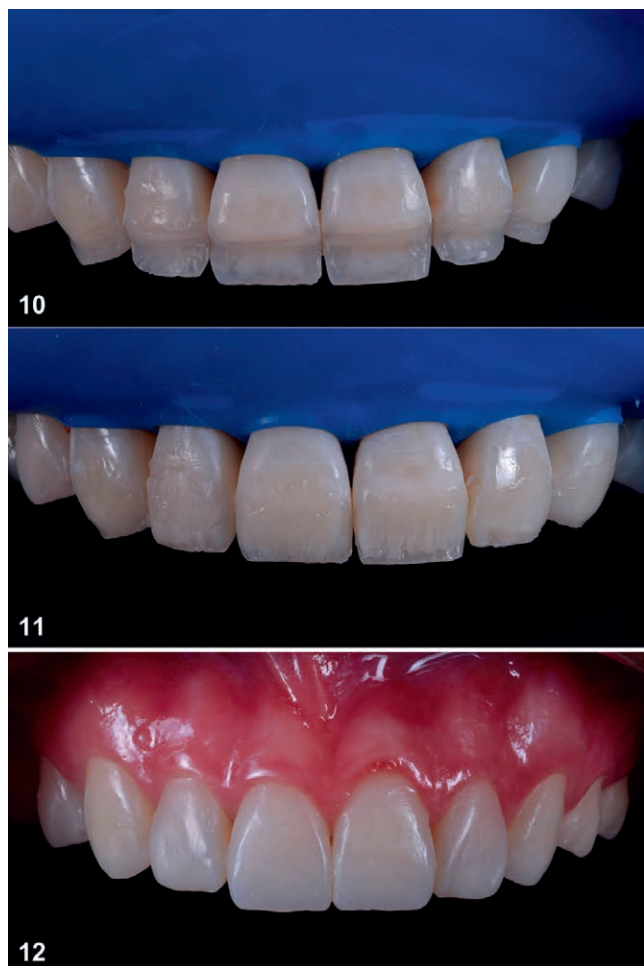
Figure 10. Luted resin veneers with excess cement removed to allow adequate space for the direct incremental technique.

Figure 11. Direct restorative procedure for the palatal luted indirect surface using the stratified restorative technique.

Figure 12. View of the buccal surface of the maxillary anterior teeth, demonstrating the reestablishment of anatomic characteristics with a natural appearance and harmony with adjacent soft tissue.

Brazil). The final aspect of the anterior restorations reestablished the esthetic and functional aspects after one week (Figure 12). Finally, an occlusal splint guard was delivered to prevent wear and fracture of the restorations.

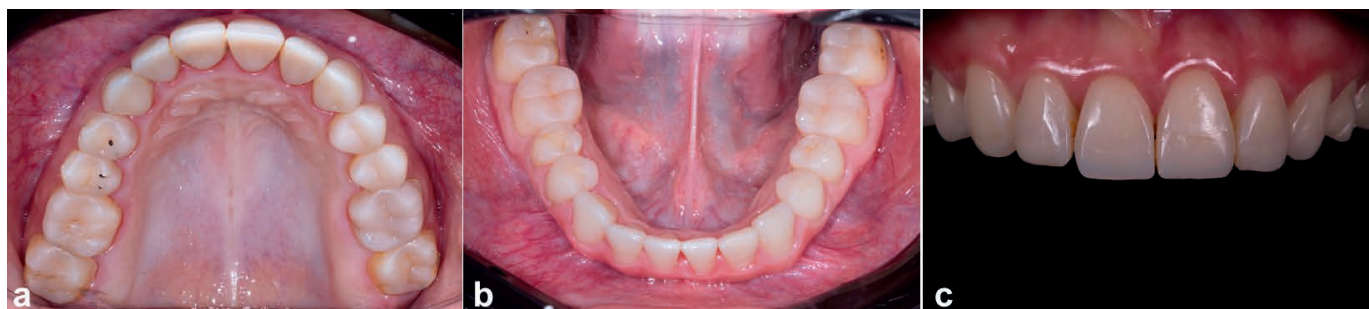
Figure 15. Views after adjustments at the four-year follow-up. (a) Occlusal view of the maxillary teeth. (b) Occlusal view of the mandibular teeth. (c) View of the maxillary anterior teeth.

Even with the presence of localized erosion, the main advantage of the use of composite resin is that it allowed for polishing, making repairs, and replacing an unsatisfactory restoration without the need for removing extra dental structure. After the four-year follow-up, the current authors detected erosive progression, especially around the buccal surfaces of the left maxillary premolars. This scenario was challenging, as the other restored areas performed well, to include minor adjustments (Figure 15). The patient reported that she had recently decided to refrain from the consumption of cola drinks, as she finally was aware of the impact of those progressive lesions.
