Three-year Follow-up of Conservative Direct Composite Veneers on Eroded Teeth

SUMMARY

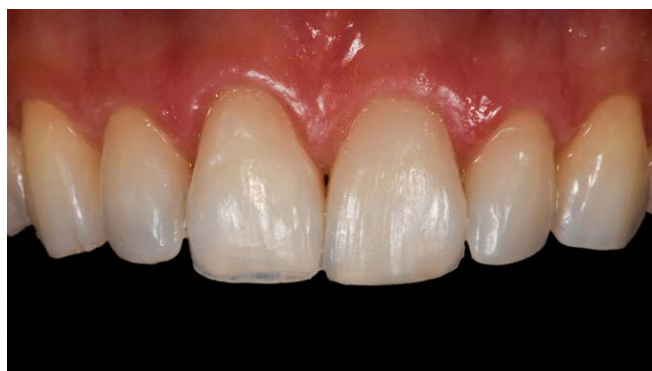
Figure 2. Resin composite mock-up to choose resin composite shades.

selected: medium dentin (MD), as dentin substitute; and light enamel (LE), as enamel substitute.

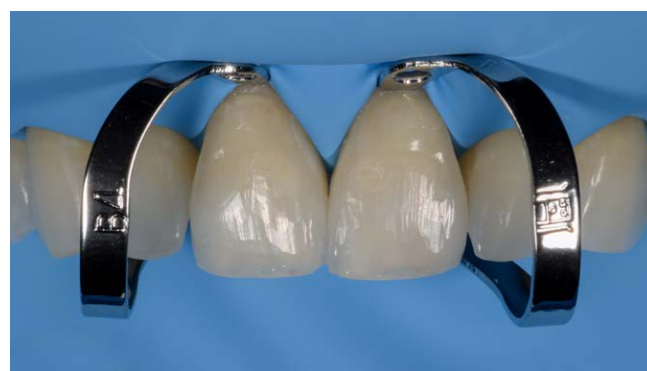
Figure 3. Rubber dam isolation using dental retainers (Hygenic Brinker B4, Coltène/Whaledent Inc). Note that the existing resin composite restorations were carefully removed. No tooth structure was removed to perform the restorative treatment.

All restorative procedures were done under rubber dam isolation (Figure 3). Dental retainers (Hygenic Brinker B4, Coltène/Whaledent Inc, Cuyahoga Falls, OH, USA) were used to reveal the cavities cervical margins. The restorative procedures were performed two teeth at a time: first the two maxillary central incisors, followed by the two maxillary lateral incisors, then the two maxillary canines. Prior to the phosphoric acid etching step, a 7.0-mm metal matrix band was positioned in the proximal surfaces to avoid acid-etching the surfaces of other teeth. Then, 35% phosphoric acid (Ultra-etch, Ultradent, South Jordan, UT, USA) was applied for 15 seconds on dentin and 30 seconds on enamel and rinsed off using copious amounts of water from dental syringe. Tooth moisture contamination was controlled using an endodontic aspirator. A two-step etch-and-rinse adhesive system (Single Bond Plus, 3M Oral Care, St Paul, MN, USA) was applied on both enamel and visibly moist dentin using a disposable brush, air-dried and light-activated for 10 seconds using a LED light-curing unit (VALO Cordless, Ultradent) with output of approximately 1,000 mW/cm². On the two maxillary central incisors and on the two maxillary canines, a first increment of resin composite (shade MD, Essentia, GC Corp) was applied on the cervical third and light-activated for 20 seconds. Afterwards, a final increment of resin composite (shade LE, Essentia, GC Corp) was applied over the entire buccal surface of the teeth and light-activated for 20 seconds. On the two maxillary lateral incisors, a single increment of resin composite (shade LE, Essentia, GC Corp) was applied on the entire facial surface of the teeth and light-activated for 20 seconds. A dental composite brush (#3, Cosmedent Inc, Chicago, IL, USA) was used in the last increment of all restored teeth in order to adapt, shape, and get a smooth surface of the resin composite. The use of a dental composite brush from

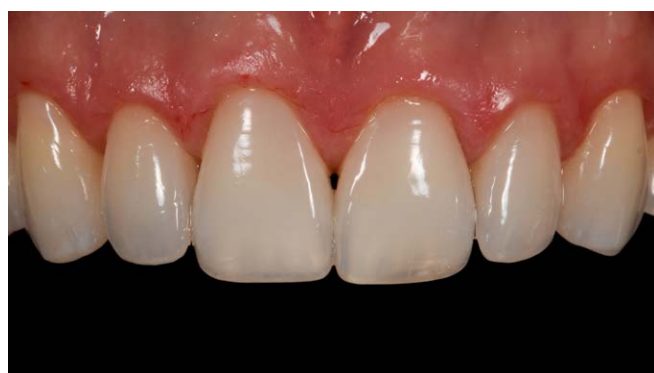
Figure 5. Final aspect of the direct resin composite veneers immediately after finishing and polishing.

(Figure 4H); 7) an aluminum oxide polishing paste (Enamelize, Cosmedent) was applied (Figure 4I) before using a felt disk (FlexiBuff, Cosmedent) (Figure 4J) for final polishing purposes to increase the gloss, luster and surface smoothness of the composite restorations (Figure 4I). The final aspect of the resin composite veneers shows a high-gloss surface (Figure 5).

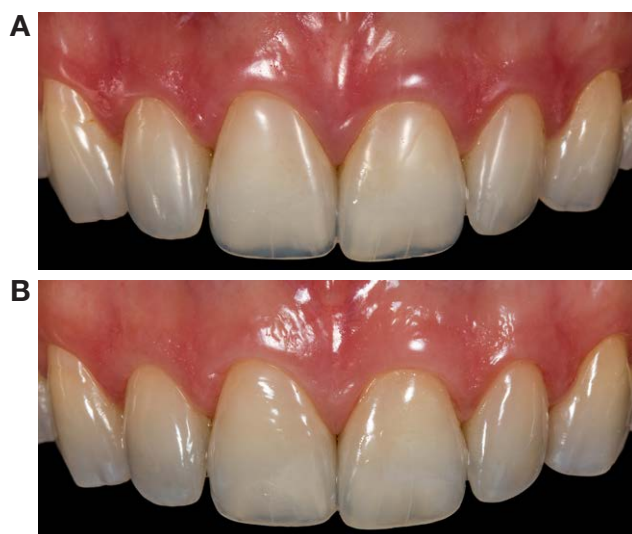
Figure 7. Three-year follow-up: (A) Initial aspect. Presence of dental plaque, mild inflammation of the gums, and absence of surface luster of the restorations; (B) One week after resin composite repair at lingual surface at incisal third (teeth 6, 8, 9, and 12) and finishing and polishing sequence. Note the absence of dental plaque, the healthy periodontal aspect, and that the surface luster of the restorations was restored.

A highly polished resin composite surface is important for both esthetic and periodontal reasons, since it helps to maintain the surface luster and color, enhancing the longevity of the resin composite restoration procedure, and reduces plaque accumulation, avoiding periodontal inflammation.²¹⁻²⁴ At the three-year follow-up clinical examination, the consequences of a rough resin composite surface could be seen as a visible biofilm and mild inflammation of the gums detected along the gingival margins (Figure 7A). One week after finishing and polishing steps, good periodontal health and surface luster of the composite restorations were seen (Figure 7B), showing the importance of maintenance polishing of resin composite restorations.

When the patient was recalled each year, polishing was performed as mentioned in steps 6 and 7 to provide maintenance of the composite restorations (Figure 6 A-C). At the three-year appointment, a satisfactory appearance of the patient's smile was still seen, showing the stable performance of the composite restorations (esthetic success) and absence of additional ETW (biological success) (Figure 7A). However, some dental plaque and chipping at gingival margins, mild inflammation of the gums, and a dull surface in all resin composite veneers could be seen (Figure 7A). Also, some wear at the lingual surface at the incisal third of the teeth 6, 8, 9, and 12 was observed. At this appointment, resin composite restorations were placed on the lingual surfaces at the incisal third of teeth 6, 8, 9, and 12 using the already mentioned etch-and-rinse adhesive system (Single Bond Plus, 3M Oral Care) and resin composite (Essentia, shade LE, GC Corp). Then, the finishing and polishing procedure of the resin composite veneers (all steps except step number 2) and the lingual composite restorations (all steps) were performed. In this way it was possible to refine the margins and to reestablish the polishing luster of the restorations. Figure 7B shows the final aspect one week after the polishing procedure from the three-year follow-up.
