# Resin Composite Restorations of Permanent Incisors with Crown Fractures: A Case Report with a Six-year Follow-up

## Clinical Relevance

The teeth in this report were restored with a two-step self-etch adhesive system and a microhybrid resin composite. The teeth present with an excellent clinical performance and patient acceptance at the end of a six-year recall.

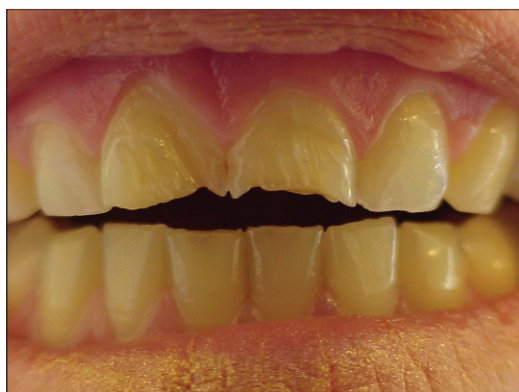
Class IV. In the cervical area of the facial surface, there was intact enamel beginning from the gingival margin and extending coronally 0.5 mm in tooth 11 and 1.5 mm in tooth 21 (Figure 1). The patient's oral hygiene level was scored as 0 according to an oral hygiene index,<sup>5</sup> and the patient had a type 1 occlusion with no parafunctional movements. Both of the fractured anterior teeth were asymptomatic and responded within normal limits to cold and electric pulp tests. No periapical disease or root fracture was diagnosed during radiographic examination.

Figure 1. Clinical appearance of the teeth before restoration.

The treatment procedure was performed as follows: a bevel was placed on the whole facial surface, beginning from the gingival margin, to allow for a gradual increase in the thickness of the resin composite. Incisal edges and corners were rounded and the bevel was extended to a 1 mm periphery on the palatal surface. A diamond bur (Bur #806 314 290 014, Acurata, Thurmansbang, Germany) was utilized on the enamel surface while the dentin was cleaned with tungsten carbide burs (Bur #500 204 001 291 018, 500 204 001 291 012, 500 204 001 291 010, Acurata). The remaining enamel and dentin surfaces were irregular and scalloped.

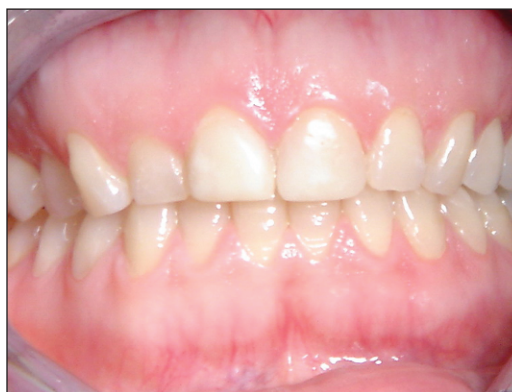
Figure 2. Clinical appearance of the teeth after restoration.

Finishing and polishing procedures were performed by discs (Sof-Lex, 3M ESPE) and diamond burs (Bur #806 314 250 514 018, 806 314 250 504 018, Acurata) and a second polishing procedure was performed at the one week recall (Figure 2). The composition and manufacturers of the materials are presented in Table 1.

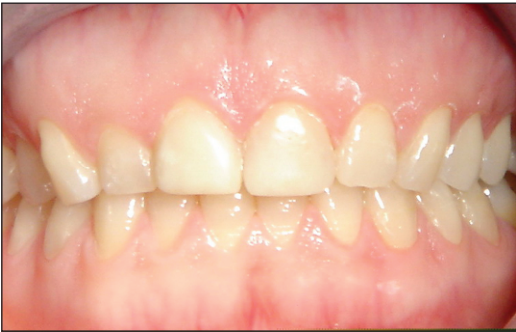
Recalls were performed at the end of two years (Figure 3) and six years (Figure 4), respectively. Rebonding was performed following polishing during both visits.

Results of the two-year follow-up were found to be excellent (Alpha scores were observed for all evaluation criteria) in terms of retention, color match, marginal discoloration, secondary caries, marginal adaptation and surface texture, according to the United States Public Health Service (USPHS) criteria<sup>6</sup> (Table 2). The restorations were found to be successful, although slight marginal discoloration (Bravo score) was observed at the six-year recall. Alpha scores were observed for other evaluation criteria at the end of six years and the patient considered the results as satisfactory.

Figure 3. Clinical appearance of the composite restoration at the end of two years.

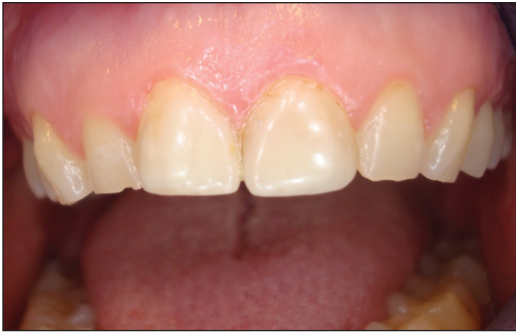
Figure 4. Clinical appearance of the composite restoration at the end of six years.
