A Conservative Technique for Repairing Class IV Composite Restorations

VC Ruschel • SC Stolf • S Shibata • LN Baratieri

The repair of the facial surface of a class IV composite restoration with poor coloration is a minimally invasive treatment that allows satisfactory restoration of esthetics and function.

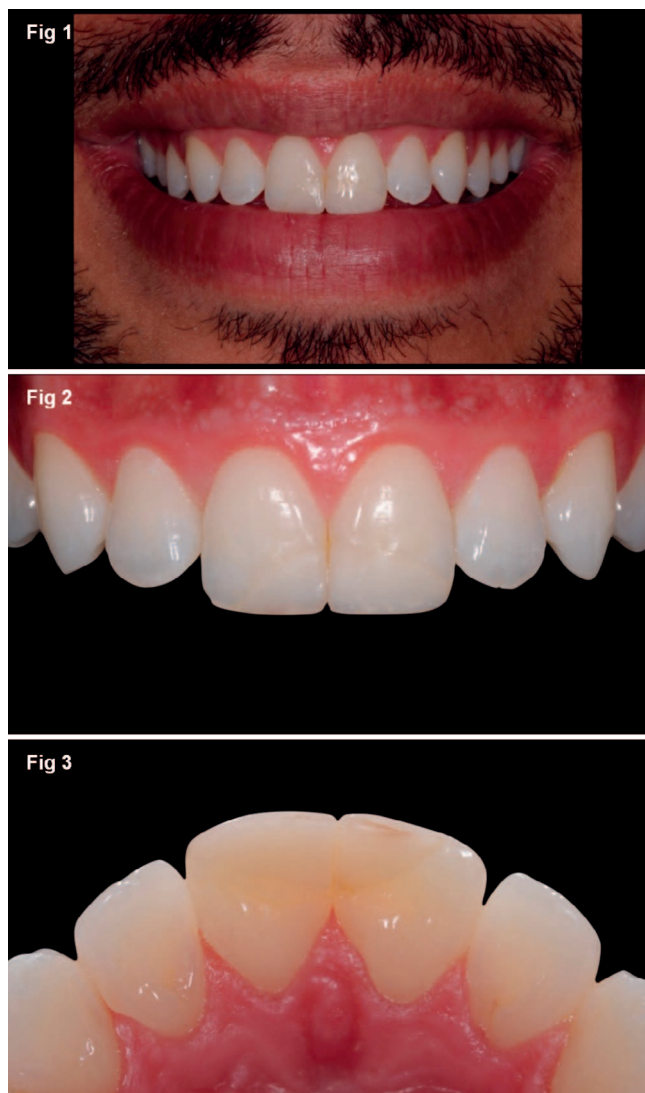
Figure 1. Initial aspects of the patient's smile. Note the unsatisfactory color of the class IV restorations in the two maxillary central incisors.

Figure 2. Intraoral view of maxillary anterior teeth.

Figure 3. Palatal view of maxillary anterior teeth. Observe that the palatal surface of the restoration in tooth No. 9 has adequate marginal adaptation, unlike the restoration in tooth No. 8.

A 22-year-old patient came to the Federal University of Santa Catarina dissatisfied with the color of 2 class IV composite resin restorations, one in the right maxillary central incisor (No. 8) and the other in the left maxillary central incisor (No. 9; Figures 1 and 2). The radiographic examination showed that the patient's teeth had normal periapical and periodontal tissues. During the clinical examination, teeth Nos. 8 and 9 showed pulp vitality. The palatal surface of the restoration in tooth No. 8 was discontinuous, featuring marginal leakage. The restoration on the palatal surface of tooth No. 9 was complete and had adequate marginal adaptation (Figure 3). The replacement of class IV restoration in tooth No. 8 and the restoration repair in tooth No. 9 were proposed to the patient.

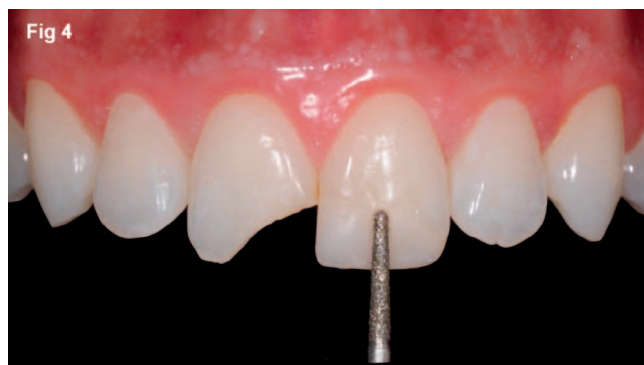
Figure 4. Restoration in tooth No. 8 removed and preparation of the facial surface of the restoration in tooth No. 9 with a tapered diamond bur.

remove the restoration in tooth No. 8 and to prepare the facial surface of the restoration in tooth No. 9 (Figure 4). The preparation was conducted to provide space for the composite resin stratification, across the entire facial surface of the restoration, respecting the inclination of the mesial and incisal thirds. In addition, the mesial surface was prepared to create space for insertion of proximal artificial enamel (Figures 5 and 6). A design of the mamelons was made in the incisal region, using a sharp-ended diamond bur (2137F, KG Sorensen), to obtain space for the reproduction of an opaque and opalescent halo (Figure 7). Afterward, a mock-up was conducted to verify the correct composite resin color selection and was left for 1 week as a temporary restoration.

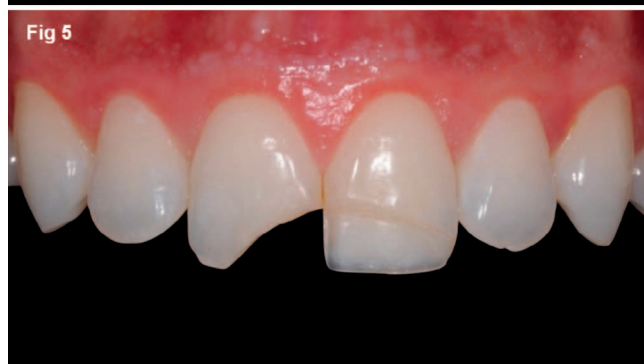
Figure 5. Aspect of the prepared facial surface of the restoration.

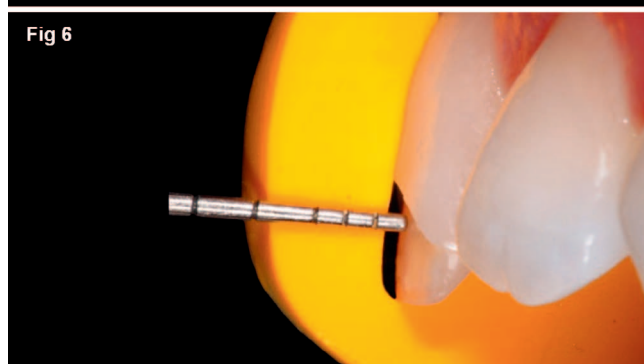
Figure 6. Lateral view of the silicone guide in position. Note that the space for insertion of the composite resin is 0.7 mm.

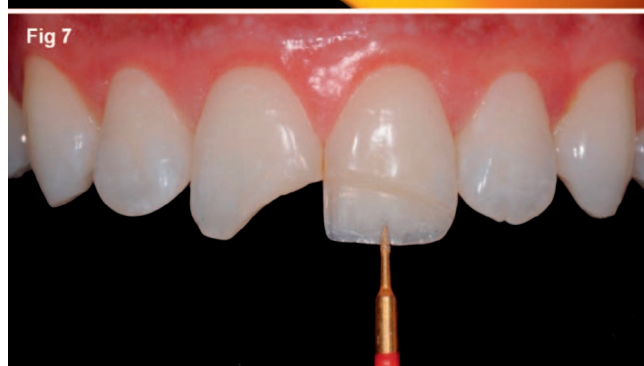
Figure 7. Design of the dentin mamelons with a sharp-ended diamond bur.

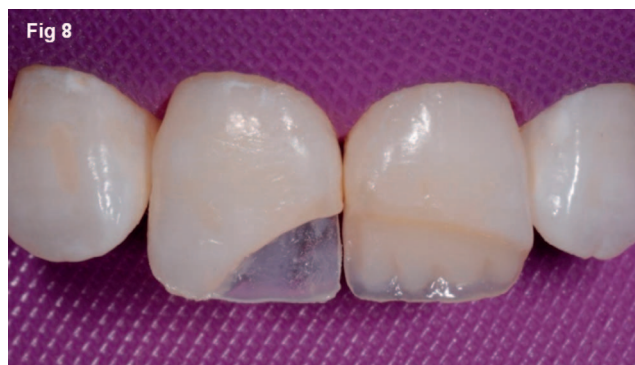
Figure 8. Intraoral view of the palatal enamel on tooth No. 8 and the preparation of tooth No. 9 after adhesive procedures.

The stratification of the composite resin on tooth No. 8 included high translucent resin EB1 (IPS Empress Direct, Ivoclar Vivadent) to reproduce the palatal enamel, using a silicone guide obtained from

the waxing (Figure 8). The incisal halo was reproduced with low translucent resin DB1 (IPS Empress Direct, Ivoclar Vivadent). Low translucent resin DA1 (IPS Empress Direct, Ivoclar Vivadent) was used to reproduce mesial thirds dentin, and low translucent resin DB1 (IPS Empress Direct, Ivoclar Vivadent) was used to reproduce incisal third dentin and dentin mamelons. A translucent resin was used (Trans 30, IPS Empress Direct, Ivoclar Vivadent) to reproduce the opalescent halo, which was lightly applied to the dentin mamelons. The facial enamel was finished with a thin layer of high translucent resin EB1 (IPS Empress Direct, Ivoclar Vivadent). The restoration in tooth No. 9 was performed with

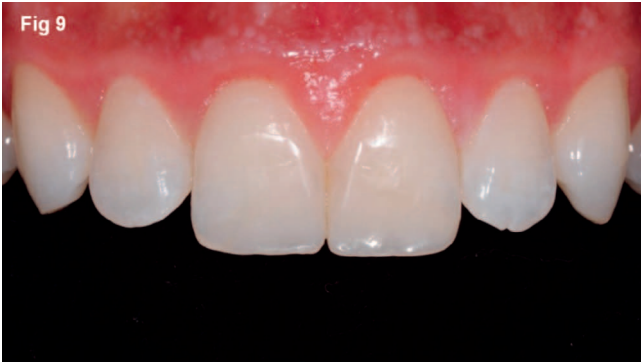
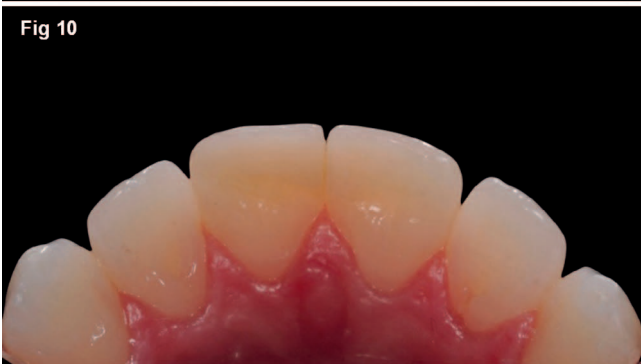
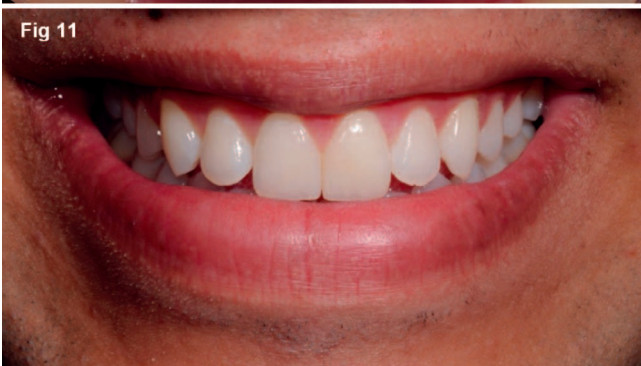
Figure 9. Aspect of the upper arch after the restoration is finished and polished.
Figure 10. Palatal view of the finalized restorations.
Figure 11. Patient's smile after restorative treatment.

In the next session, the finishing and polishing procedure was initiated with abrasive strips (3M ESPE) on the proximal surfaces. The facial surfaces were finished with sequential polishing discs of decreasing grit size (Sof-Lex Pop On, 3M ESPE). A carbide bur (FG 7664F, KG Sorensen) was used to remove excess resin from the preparation margin and to reproduce vertical texture. A felt disc (Diamond Felt Disc, FGM, Joinville, SC, Brazil) with diamond polishing paste (Diamond Excel, FGM; Figures 9-11) was used to perform the final polishing.

In this clinical case, the replacement of the class IV restoration in tooth No. 8 was necessary because of the presence of a defect in the interface between the palatal surface and the restoration. This condition contraindicates facial surface repair because of possible early restoration failure. The restoration in tooth No. 9 could be repaired because of the optimal marginal adaptation of the palatal surface. However, the final esthetic result between the repaired restoration and the replaced restoration was similar, and both were satisfactory.
