# Ferrule-Effect Dominates Over Use of a Fiber Post When Restoring Endodontically Treated Incisors: An *In Vitro* Study

P Magne • PC Lazari • MA Carvalho • T Johnson • AA Del Bel Cury

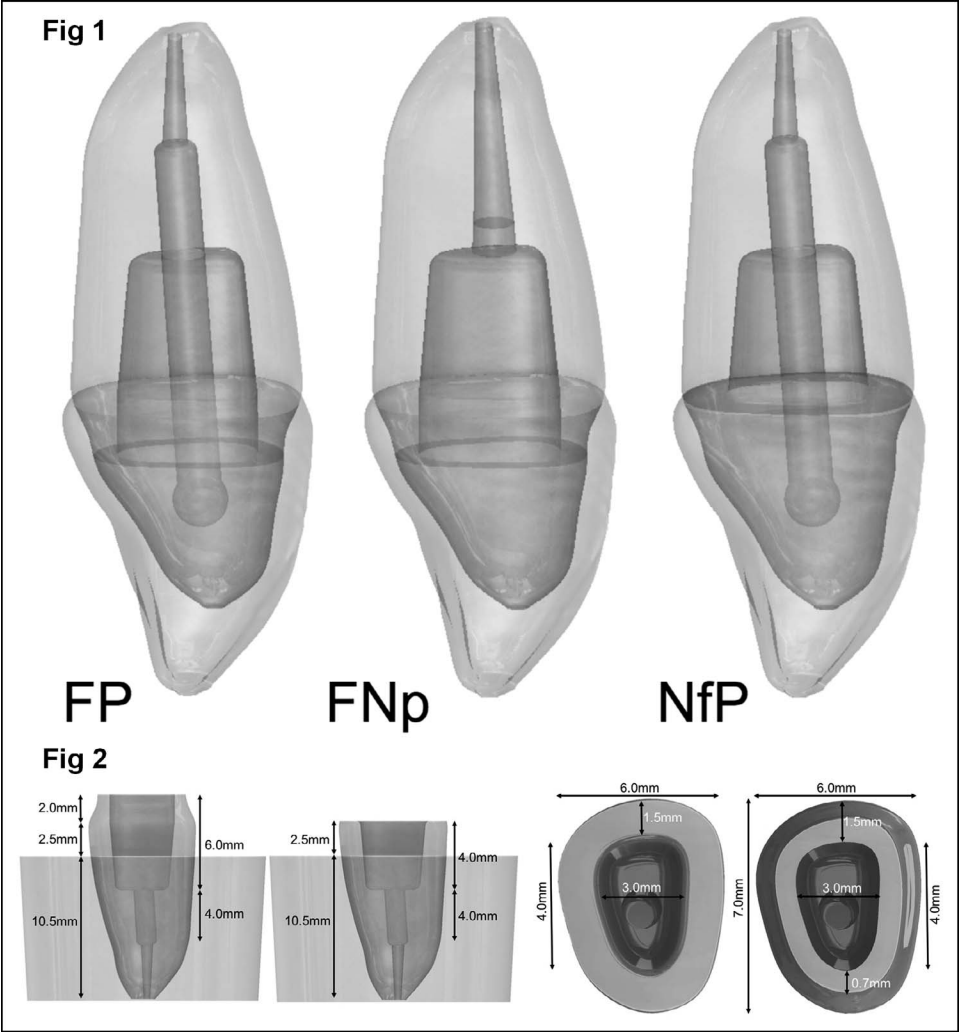
Figure 1. Schematic views of restored endodontically treated incisors. (A): Group FP. (B): Group FNp. (C): Group NfP. Figure 2. Schematic view of root dimensions before restoration.

post and resin core buildup, FNp = ferrule and direct resin core buildup, or NfP = no ferrule with GFR post and resin core buildup (Figures 1 and 2). The specimens were mounted in a special positioning device with acrylic resin (Palapress Vario, Heraeus Kulzer, Armonk, NY, USA) embedding 11.5 mm of the root. For the ferrule groups, the specimens were prepared with a tapered round-ended diamond bur (Brasseler, Savannah, GA, USA), creating a 2-mm-high/1-mm-thick circular ferrule and a 0.8-mm horizontal circular chamfer (cervical limit). Table 1 presents the brand, company and qualitative composition information of materials used in the present study.

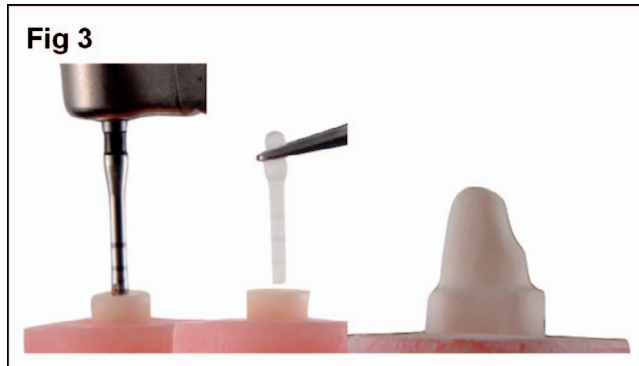
Figure 3. Post insertion and buildup.

Lux (no. 6, 1.5-mm diameter, Coltène Whaledent, Altstätten, Switzerland) (Figure 3). Using a cutting disc, the apical portion of the posts was removed to obtain a length of 11 mm (8 mm below and 3 mm above the cervical limit of the crown preparation). Prior to the luting procedure, the posts were cleaned with alcohol and air-dried. The post space walls were lightly coated with cement (RelyX Unicem 2 Automix, 3M ESPE, Seefeld, Germany), and the post was inserted. Cement excesses were cleaned, leaving 4 mm of post height in the cement. The cement system was light cured for 40 seconds (VALO Curing Light, Ultradent Products, Inc, South Jordan, UT, USA). After post cementation, the exposed dentin walls and the post were sandblasted with 30- $\mu$ m silicated  $\text{Al}_2\text{O}_3$  powder (Rocatec Soft, 3M ESPE). Silane (Ceramic Primer, 3M ESPE) was applied to the post head and air-dried. For dentin bonding purposes, 35% phosphoric acid (Ultra-Etch, Ultradent Products) was used for etching for 10 seconds, dentin walls and post rinsed and gently dried, followed by application of the adhesive system (Optibond FL Primer and Adhesive, Kerr, Orange, CA, USA) and light curing for 40 seconds (VALO Curing Light). All buildups were obtained with five to six 2-mm-thick increments of Miris 2 (Coltène Whaledent), each polymerized at 1000  $\text{mW}/\text{cm}^2$  (VALO Curing Light) for 40 seconds. An air-blocking barrier (KY Jelly, Johnson & Johnson Inc, Montreal, QC, Canada) was used to cover the preparation surface, and additional polymerization was carried out for 10 seconds per surface. Special care was taken to shape the Miris 2 buildup ideally in order to avoid any further corrections of the preparation surface and margins. All buildups were 11 mm high (4 mm internal and 7 mm above the cervical limit of the crown preparation).

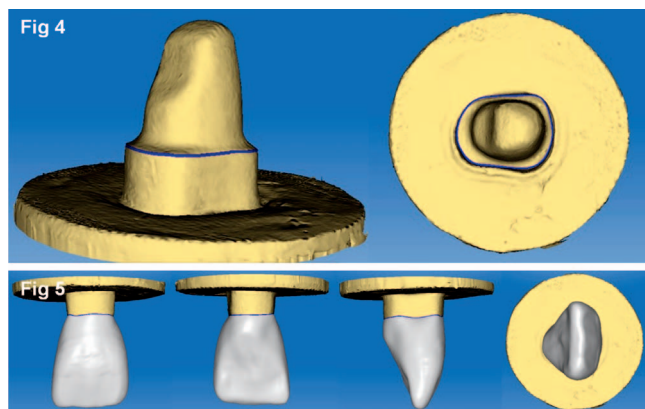
Figure 4. CAD data set of preparation with preparation line.

Figure 5. Standardization of crown design using Cerec software. All crowns were 11 mm high and 9 mm in mesial–distal width.

All bonded ceramic crowns were fabricated using the Cerec 3 CAD/CAM system (Sirona Dental Systems GmbH, Bensheim, Germany). Digital impressions of the prepared teeth were performed with Cerec Blue Cam, using a contrast powder (IPS Contrast Spray Chairside, Ivoclar Vivadent). The specimens were fitted with a crown of standardized thickness and anatomy with 11-mm incisio-cervical length and 9-mm mesio-distal width. All crowns were milled in lithium disilicate ceramic (IPS e.max CAD, Ivoclar Vivadent) using the “crown mode” with the sprue located at the lingual surface. After milling, lithium disilicate restorations were glazed, crystallized, and fired according to the manufacturer’s protocol (Programat CS, Ivoclar Vivadent) using IPS Object Fix Putty and IPS e.max CAD Crystall/Glaze Spray (Ivoclar Vivadent). The steps of digital design as well as the final restoration are presented in Figures 4 through 6.

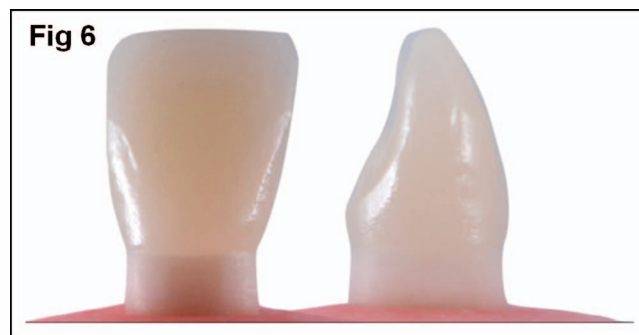
Figure 6. Final assembly after cementation.

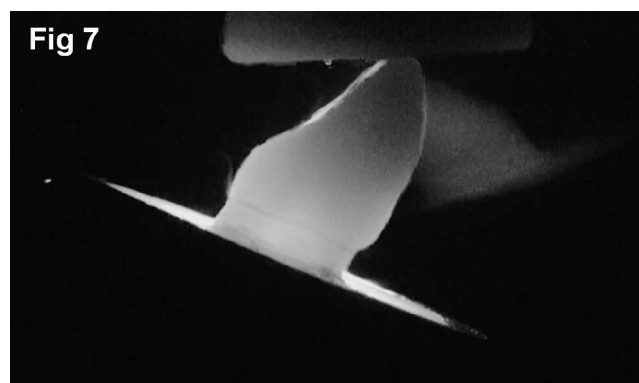
Figure 7. Specimen in the load chamber. Cyclic isometric loading was applied to the incisal edge at an angle of 30°.

Masticatory forces were simulated in an artificial mouth using a closed-loop electrodynamic system (Acumen 3, MTS Systems, Eden Prairie, MN, USA). The chewing cycle was simulated by an isometric contraction (load control) applied through a flat composite resin antagonist (Z100, 3M ESPE). The force was applied at a palatal angle of 30° with the flat surface contacting three-fourths of the incisal edge (Figure 7). The load chamber was filled with distilled water to submerge the sample during testing. A cyclic load was applied at a frequency of 5 Hz, starting with a load of 100 N (warm-up of 5000 cycles), followed by stages of 200, 300, 400, 500, 600, 700, 800, 900, and 1000 N at a maximum of 15,000 cycles for each force. Samples were loaded until fracture or to a maximum of 140,000 cycles.

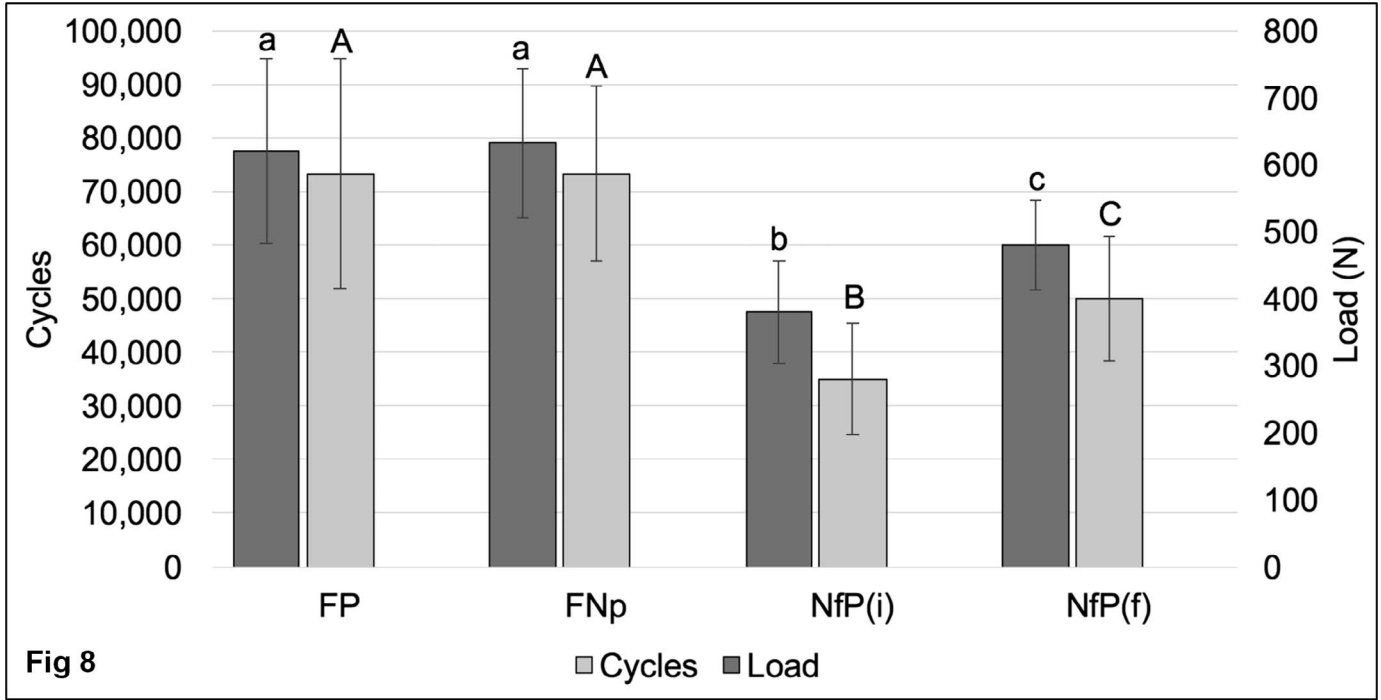
Figure 8. Mean fracture loads (dark gray) and average number of survived load cycles (light gray) and their standard deviations, respectively.

None of the specimens withstood all 140,000 load cycles. As all specimens fractured, the mean fracture load/cycles could be calculated (Figures 8 and 9). During cyclic loading, initial failures were detected in 81% (12/15) of the specimens in the no-ferrule group and 14% (2/15) and 7% (1/15) for a ferrule with a post and a ferrule without a post, respectively. The initial failure phenomenon can be described as the opening of a wide gap between the buildup/crown assembly and the root. The gap was always located at the lingual margin. Because clinical detection of such initial failures appears to be questionable, the analysis of survival was conducted for both the “final failure” (NfP[f]) and the “initial failure” (NfP[i]). The initial failure (i) values were recorded by reviewing the motion picture (high-definition macro mode) of the entire test for each specimen. Initial failure was easily detected by a significant high-pitched noise and simultaneous opening of a wide gap with emission of debris and air bubbles. The final failure (f) values were obtained by the testing machine when the sample completely fractured, causing the

One-way ANOVA and the Tukey test revealed that the mean fracture load for the FP group ( $620.00 \pm 137.32$  N;  $p = 0.984$ ) showed no statistical difference when compared with the FNp group ( $633.33 \pm 111.2697$  N;  $p = 0.984$ ). Ferrule groups were significantly higher than the NfP group ( $380.00 \pm 77.4596$  N [i],  $480.00 \pm 67.6123$  N [f]) considering the initial and final failure ( $p < 0.001$ ). The same results were found when the number of survived cycles was statistically compared (FP group to FNp group:  $p = 1.000$ ; FP group to NfP group:  $p < 0.01$ ; FNp group to NfP group:  $p < 0.01$ ). Figure 8 shows the mean values of fracture loads and survived cycles and their standard deviations, respectively.

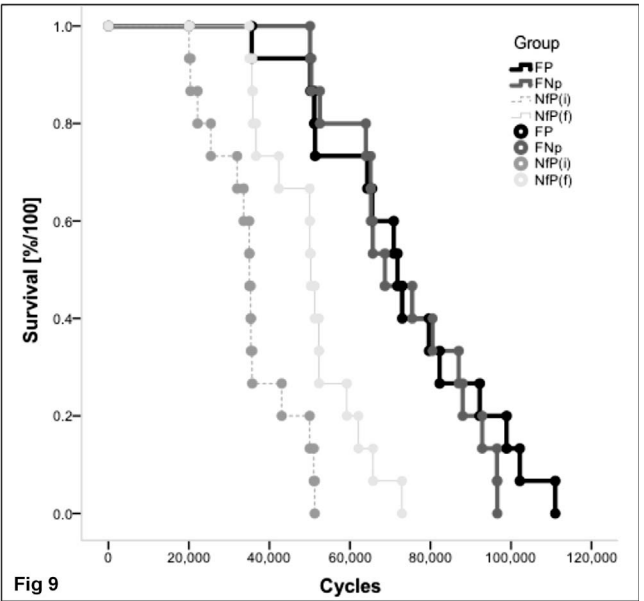
Figure 9. Kaplan-Meier survival graphs for groups FFp, FNp, and NfP. For better comparison, the survival graph of group NfP was divided into initial failure and final failure.

The Kaplan-Meier survival graphs for all groups are displayed in Figure 9. The log-rank test showed significantly higher survival of groups with a ferrule

compared to groups without a ferrule ( $p < 0.001$ ). No difference could be found between groups with ferrule ( $p = 0.488$ ). Also when considering the initial failure, the log-rank test showed the same results; that is, a significantly higher survival of the ferrule group compared to the no-ferrule group ( $p \leq 0.001$ ) and no statistical difference between ferrule groups ( $p = 0.508$ ).

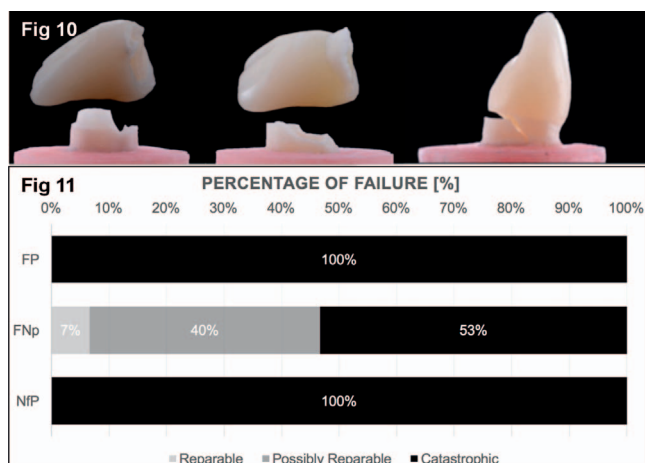
Figure 10. All specimens were analyzed and classified in one of the three failure modes: "reparable" fracture (cohesive or cohesive/adhesive fracture of restoration only), "possibly reparable" (cohesive/adhesive failure with fragment and minor damage, chip, or crack, of underlying tooth structure) or "catastrophic" (tooth/root fracture that would require tooth extraction).

Figure 11. Percentage of specimens per group for each fracture mode.

Groups with fiber post showed 100% catastrophic failures, while the no-post group presented 47% noncatastrophic failure. Possible fractures of the roots were made visible by transillumination in order to classify the specimen correctly (Figure 10). Figure 11

provides the number of specimens and percentage of each specific fracture mode for each group.
