# Ultrathin CAD-CAM Ceramic Occlusal Veneers and Anterior Bilaminar Veneers for the Treatment of Moderate Dental Biocorrosion: A 1.5-Year Follow-Up

TH Resende • KR Reis • LH Schlichting • P Magne

DOI: 10.2341/17-007-T

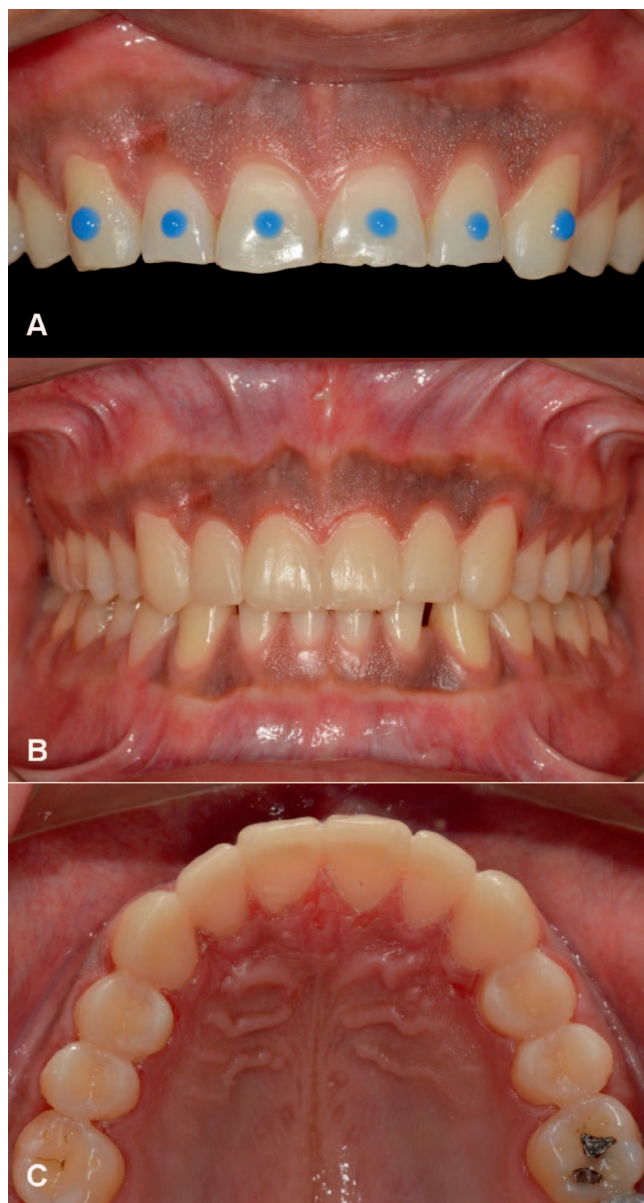
Figure 3. (A): Spot etching on unprepared enamel previous to mock-up fabrication. (B): Maxillary and mandibular mock-up (vertical dimension of occlusion increased by 1 mm). (C) Occlusal view of the posterior splinted provisional acrylic restorations.

At the next appointment, mock-up restorations were fabricated intraorally for esthetic and VDO evaluation. Multispot etching on unprepared enamel was carried out to increase the retention of provisionals in poly(methyl methacrylate) resin (Dencôr Lay, Clássico, São Paulo, Brazil) (Figure 3A). The

influence of the new VDO (+1 mm) in facial appearance as well as muscular comfort was evaluated for 15 days with splinted bonded provisional acrylic restorations (Figure 3B,C).<sup>19</sup> On the patient's approval, the provisional restorations were used as a reduction guide for the preparations with tapered diamond rotary instruments (product code 850.31.023 FG; Brasseler, USA). Depth cuts were marked with a pencil. The remaining acrylic was removed with an instrument, and preparation was completed by reducing between the guide grooves and erasing the pencil marks (Figure 4A,B). The average occlusal clearance was 0.4 to 0.6 mm (central groove) and 1.0 to 1.3 mm (cusp tips), generating minimal space for ultrathin occlusal veneers. After preparation, a rubber dam was placed, and areas of exposed dentin were refreshed with a coarse diamond bur at a maximum of 1500 rpm. Immediate dentin sealing (IDS) was achieved using a three-step etch-and-rinse dentin bonding agent (OptiBond FL, Kerr Corp, Orange, CA, USA) (Figure 4C)<sup>13-15</sup> according to the manufacturer's instructions. IDS was carried out without air thinning of the adhesive and with an additional light polymerization at 1000 mW/cm<sup>2</sup> (Valo, Ultradent Products Inc, South Jordan, UT, USA) for 10 seconds under an air barrier (K-Y Jelly, Johnson & Johnson, New Brunswick, NJ, USA) to reduce the oxygen inhibition layer. Excess adhesive resin and irregularities were then removed from the surrounding enamel by using a round diamond rotary cutting instrument (801.31.023 FG, Brasseler, USA) or tapered burs (850.31.023 FG, Brasseler, USA) at 1500 rpm (Figure 4D). Among the most reliable contemporary systems, OptiBond FL is especially indicated for the application of IDS because of its ability to form a consistent and uniform layer (about 80  $\mu$ m when placed over a slightly convex dentin surface) and its cohesiveness with the final luting composite.

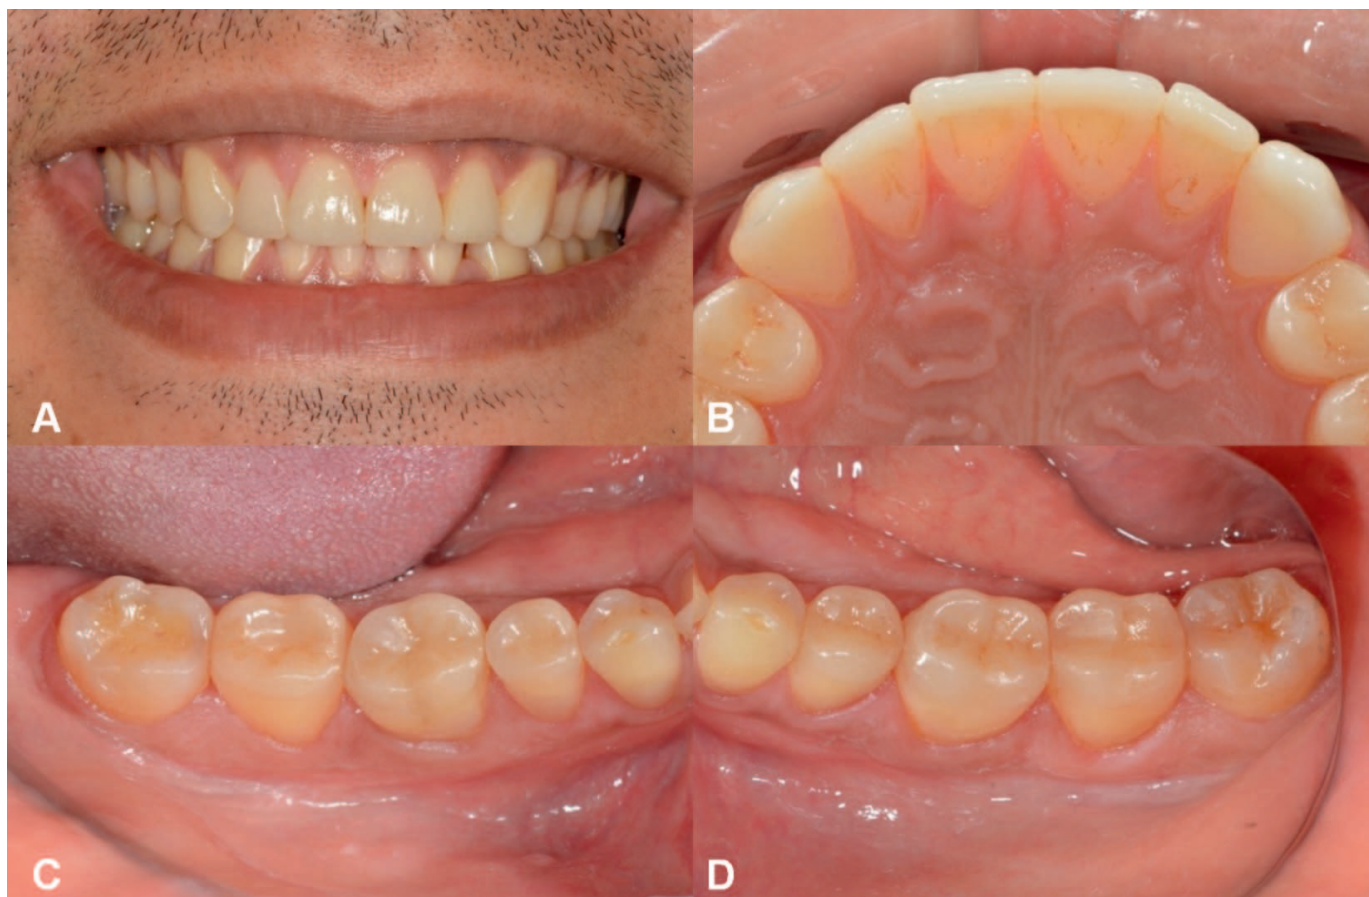
Figure 10. 1.5-year follow-up. (A): Restorations well integrated in the smile. (B) Palatal view of the anterior teeth. Note the subtle blending between composite - ceramic. (C-D): Lower posterior teeth (no signs of cracks or chipping in the restorations).

The intraoral aspects of the patient can be observed before treatment (Figure 1A through 1C), after treatment completion (Figure 9A through 9E), and after 1.5 years of treatment (Figure 10A through 10D).
